1979 Hatteras 58 Cockpit Motor Yacht
"NAN SEA GALE"

Report of Marine Survey

1979 Hatteras 58 Cockpit Motor Yacht

09 July 2013

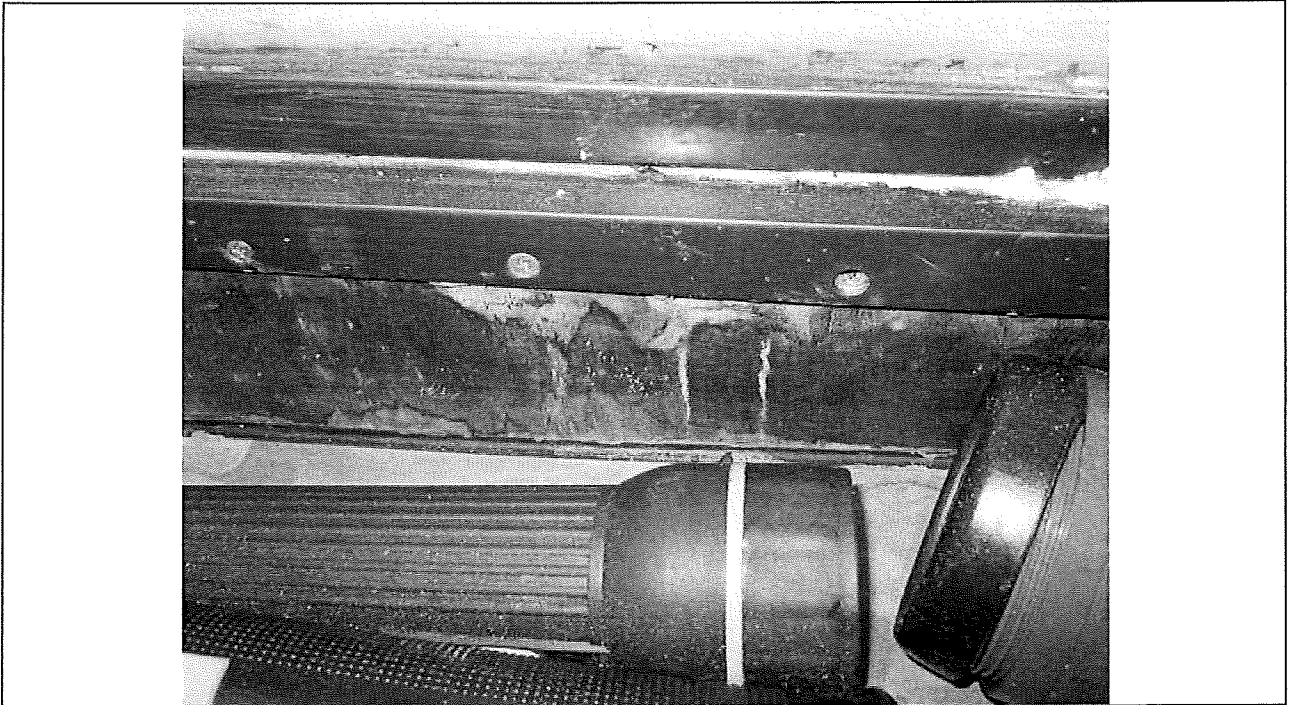
Evidence of water intrusion was noted in way of the port and starboard window frames and at the aft port corner of the aft stateroom. Water damage was noted on interior laminates in way.

INDICATIVE OF WATER INTRUSION DAMAGE AT WINDOW FRAMES

FINDINGS	RECOMMENDATIONS
Evidence of water intrusion was noted in way of the port and starboard window frames and at the aft port corner of the aft stateroom. Water damage was noted on interior laminates in way.	<i>Remove port and starboard windows, reef bedding area and reseal windows.</i>

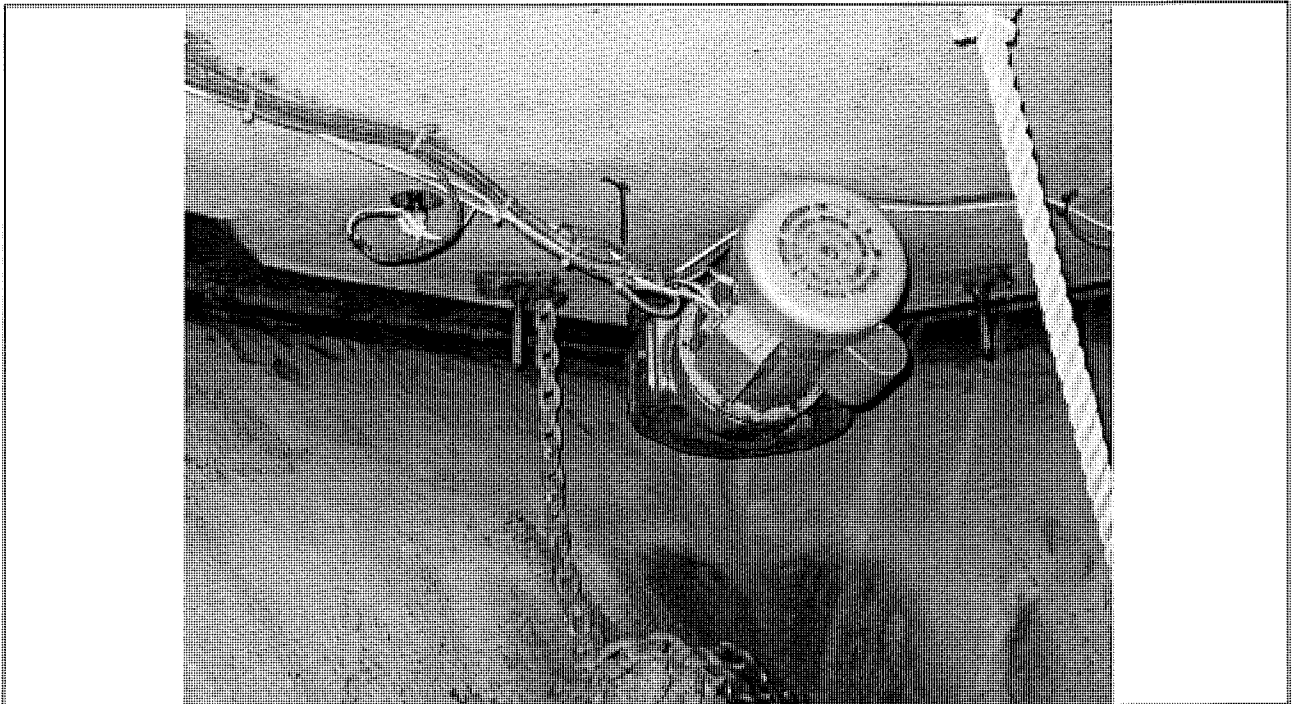
WINDLASS MOTOR

Galley Maid 32VDC windlass tested operable. Surface corrosion was noted on the windlass motor.

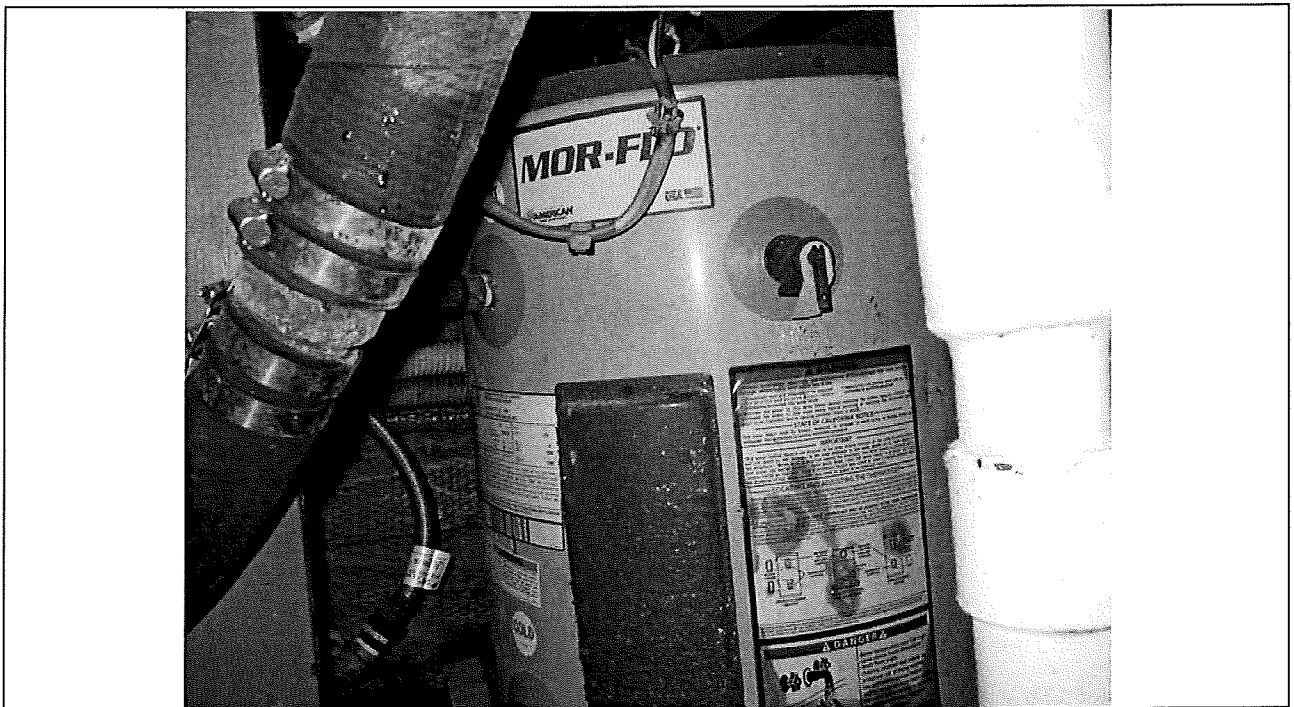
HOT WATER HEATER

Mor-Flo Model E51-20U-0155V. Corrosion was noted at the base of the hot water heater and the mounts.

Corrosion was noted on the hot water heater pressure relief valve.

FINDINGS	RECOMMENDATIONS
Corrosion was noted at the base of the hot water heater and the mounts.	<i>Clean and coat to protect.</i>

FINDINGS	RECOMMENDATIONS
Corrosion was noted on the hot water heater pressure relief valve.	<i>Clean valve.</i>

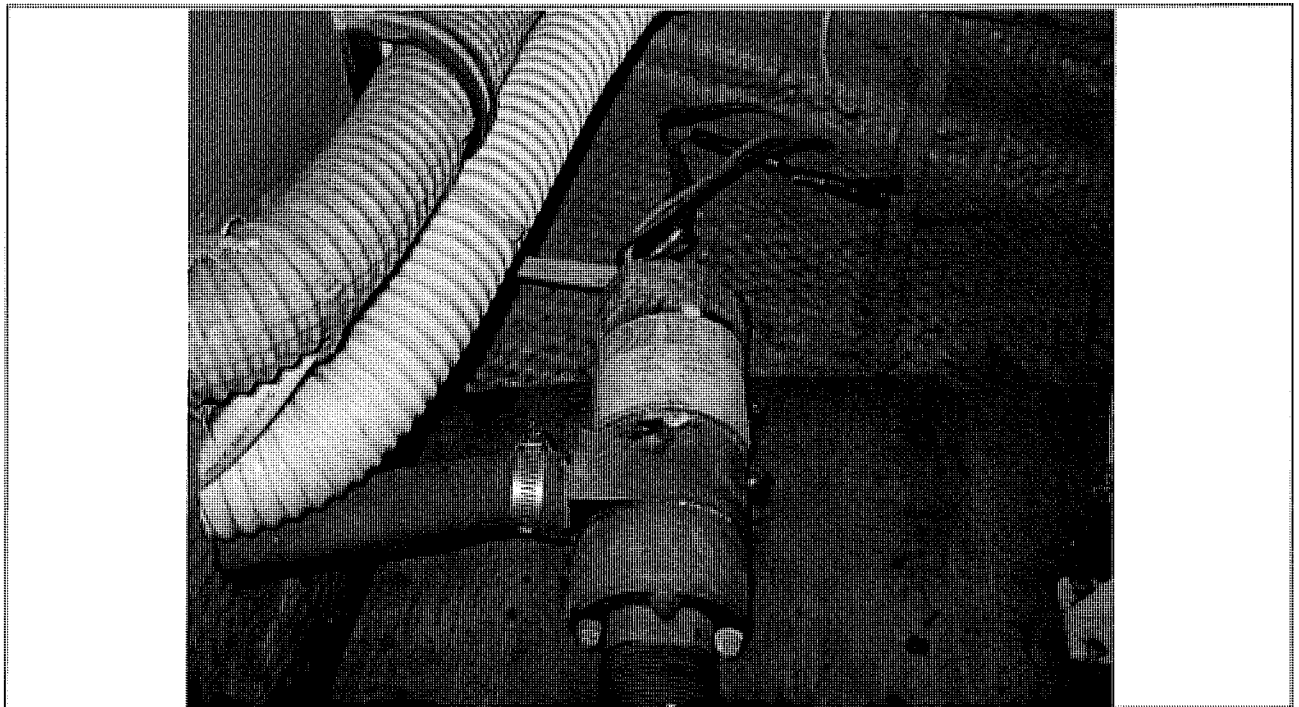
HOLDING TANK MACERATOR PUMP

Jabsco Model 18590-0002 32VDC macerator pump did not operate when tested. Surface corrosion was noted on the holding tank macerator pump. (1) Hose clamp at the holding tank macerator pump was found to be broken.

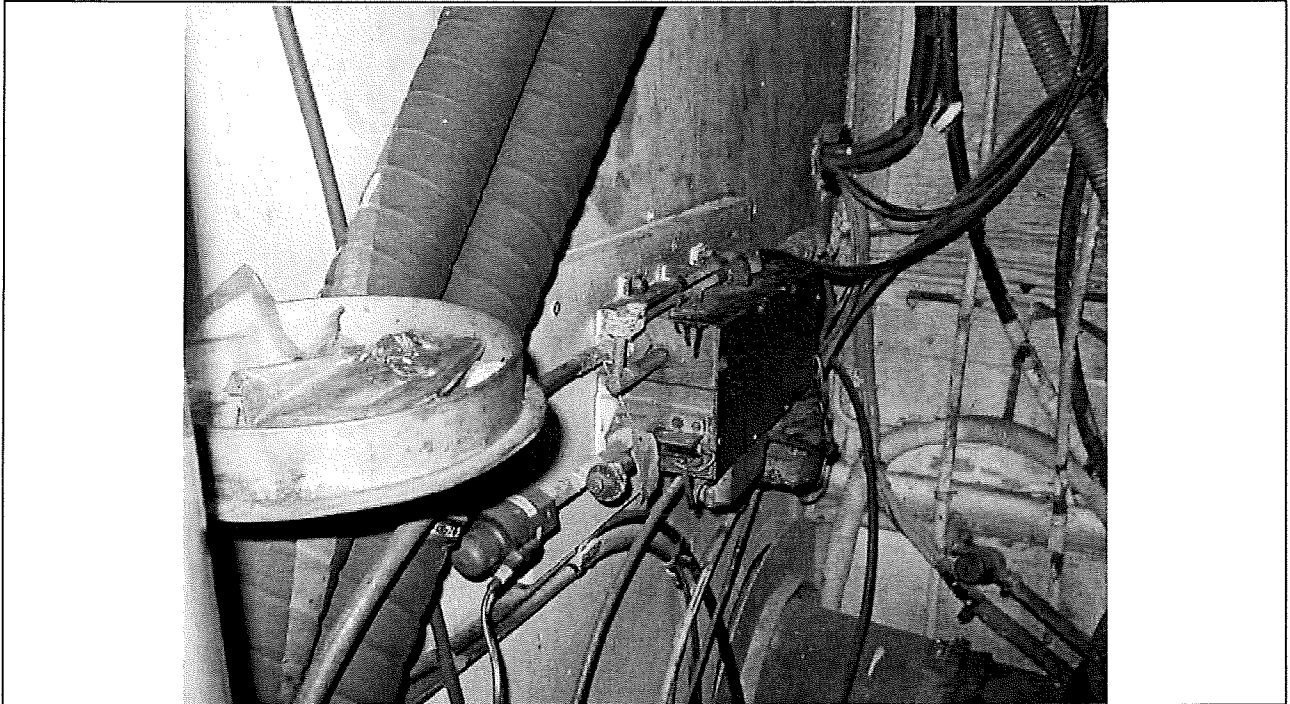
ENGINE SYNCHRONIZER

Glendinning engine synchronizer did not operate when tested. Corrosion was noted on the linkage connections at the engine synchronizer.

FINDINGS	RECOMMENDATIONS
Corrosion wks noted on the linkage connections at the engine synchronizer.	<i>Clean connections.</i>

FINDINGS	RECOMMENDATIONS
Glendinning engine synchronizer did not operate when tested.	<i>Repair as necessary.</i>

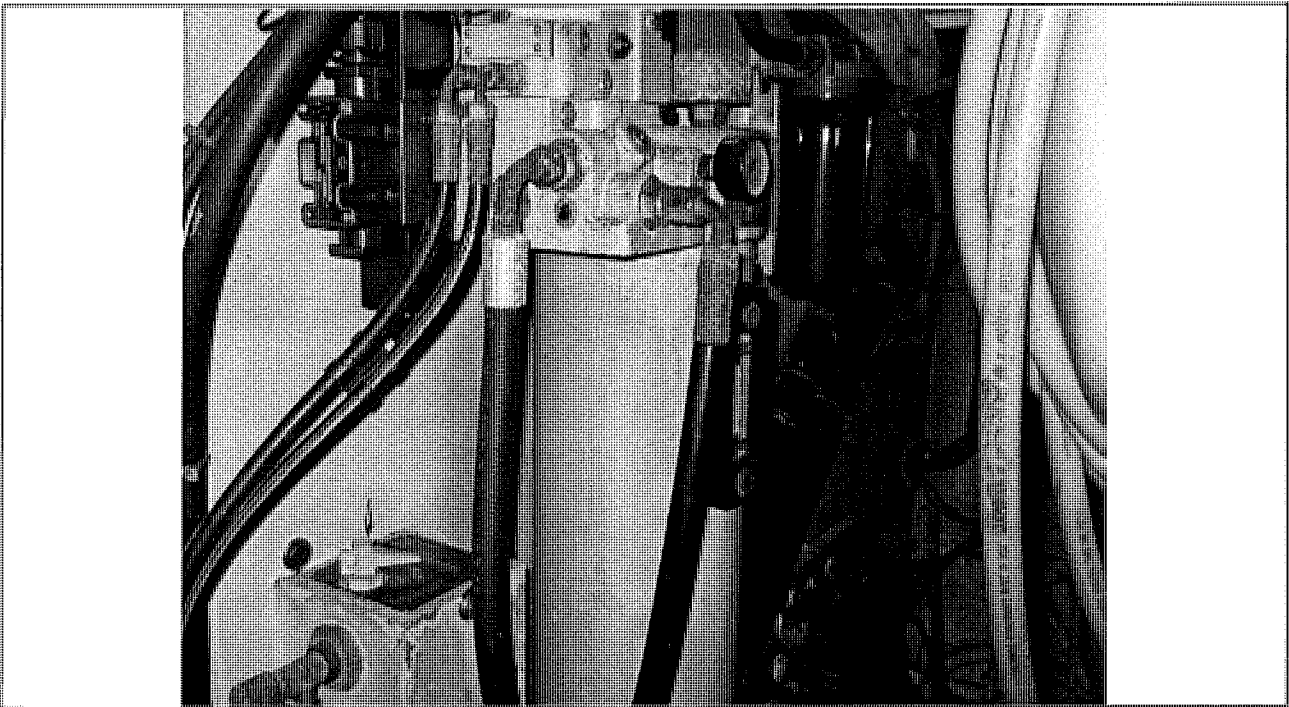
ROLL STABILIZER

ROLL STABILIZER:
***B56, B57**
NAIAD Roll Stabilizer did not power up when tested.
Corrosion was noted on the roll stabilizer system hydraulic hose compression fittings and linkage.

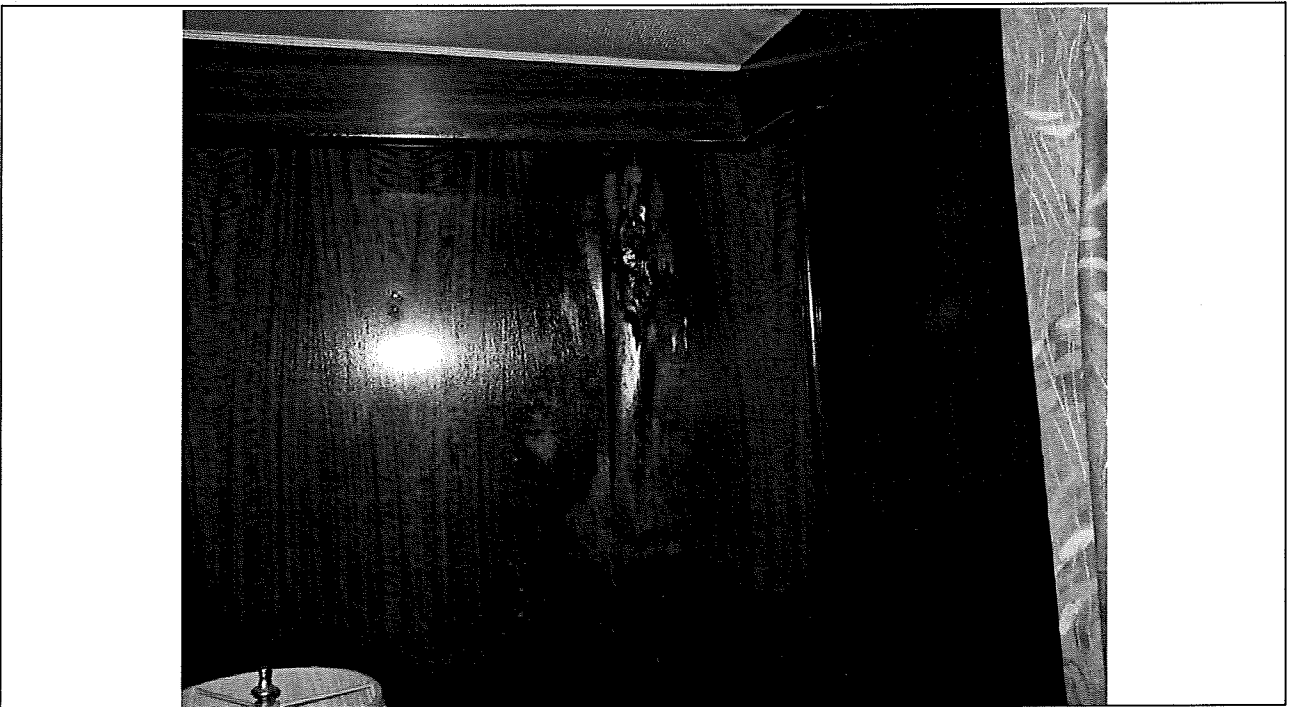
WATER INTRUSION TO AFT STATEROOM
