**2006 CARVER 56 VOYAGER  
PHOTOGRAPHS**

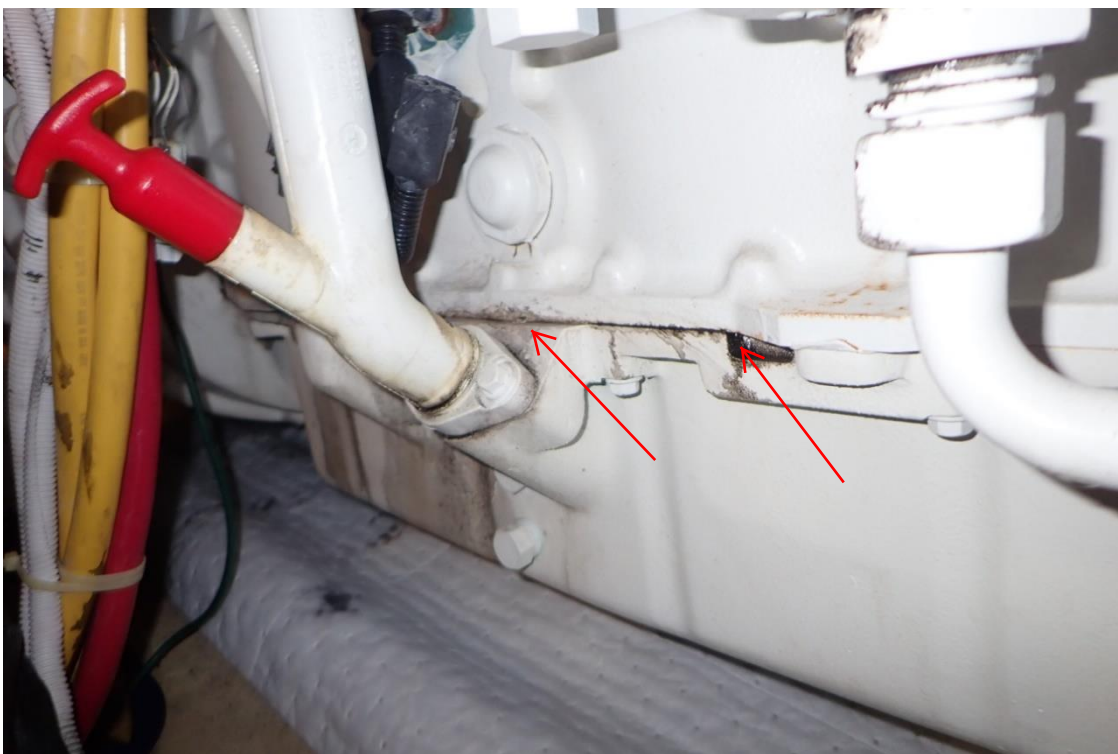
8. Oil leak at oil pan gasket, port engine

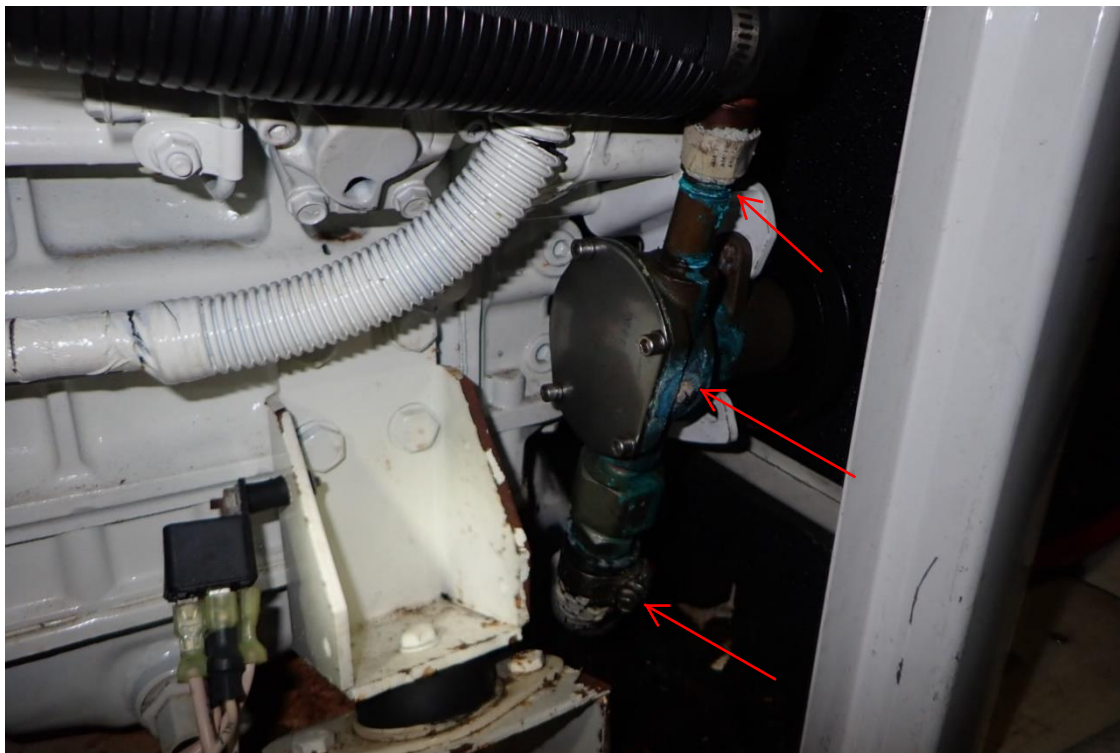
9. Leaking raw water pump at generator

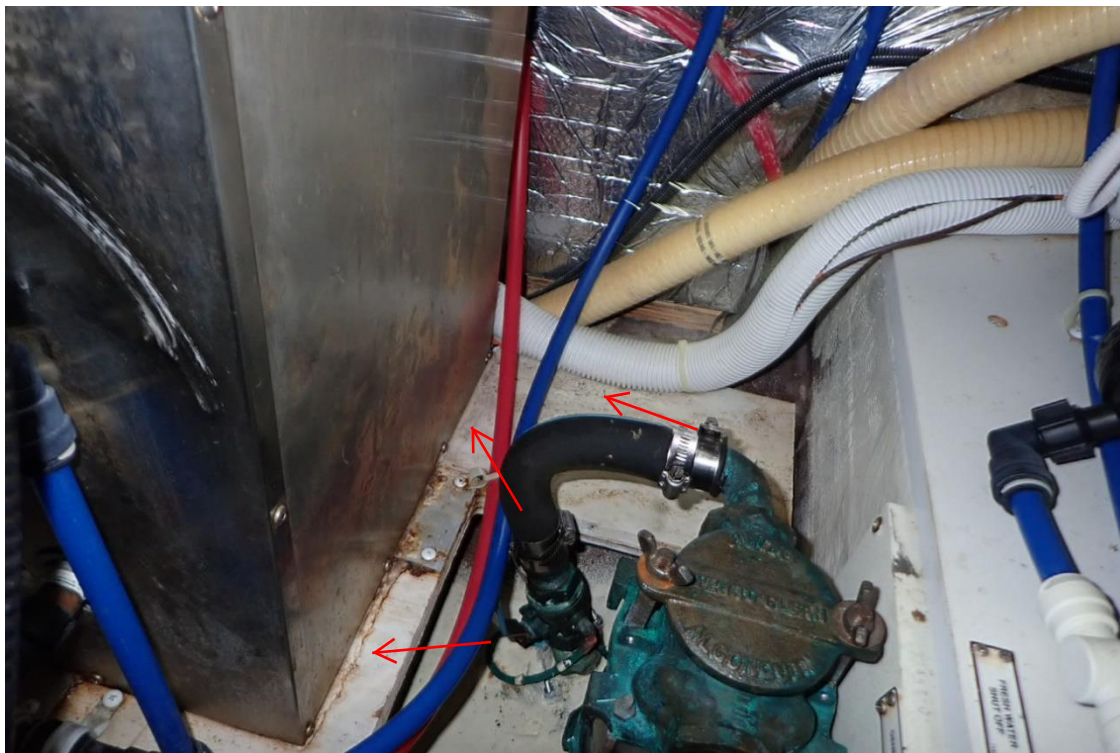
11. Standing water from apparent leak at water heater shelf

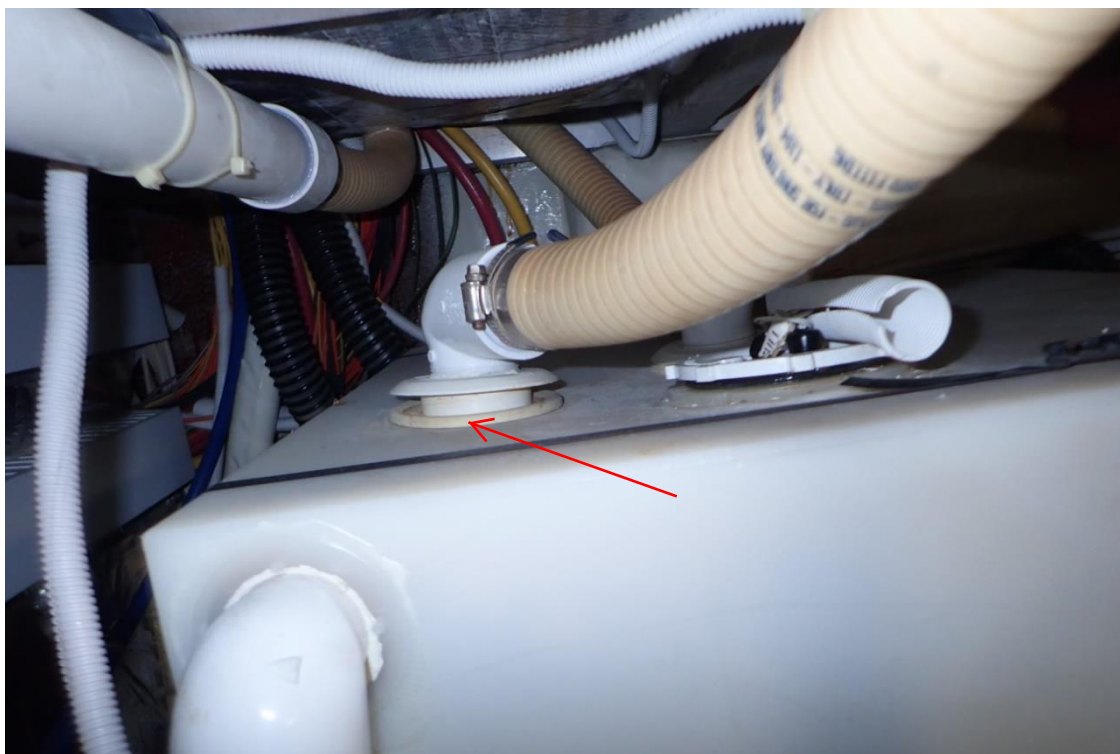
12. Loose fittings at starboard waste tank

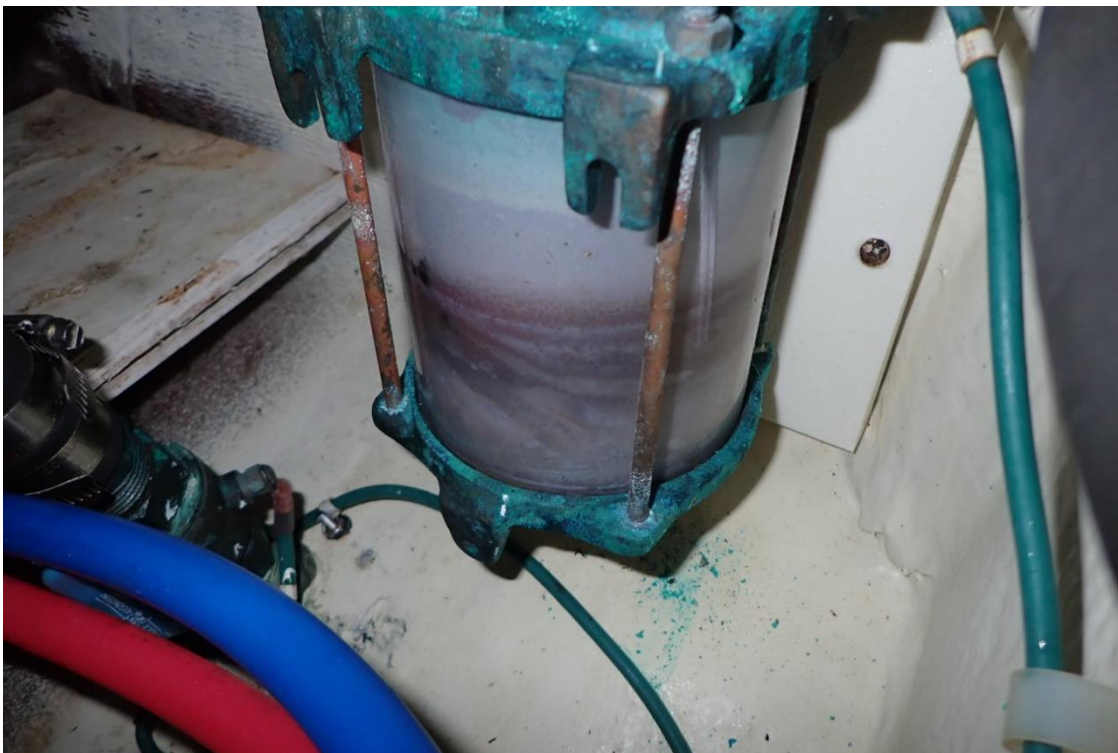
13. Generator seastrainer fouled

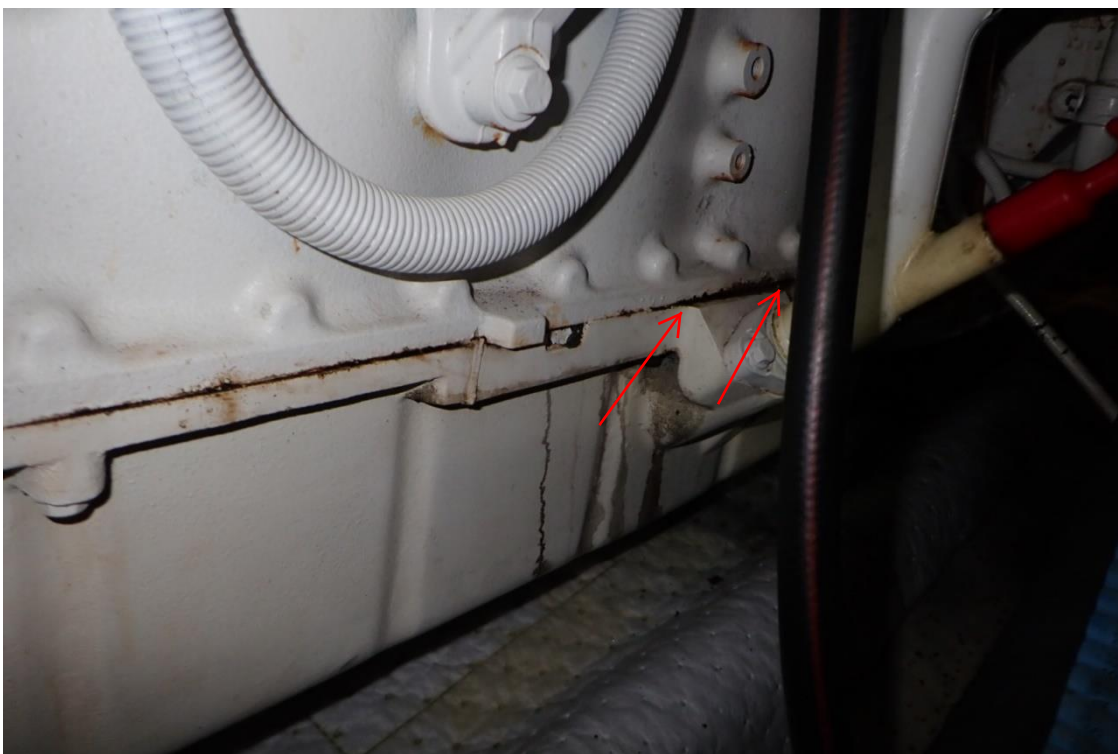
14. Starboard engine oil pan gasket leak

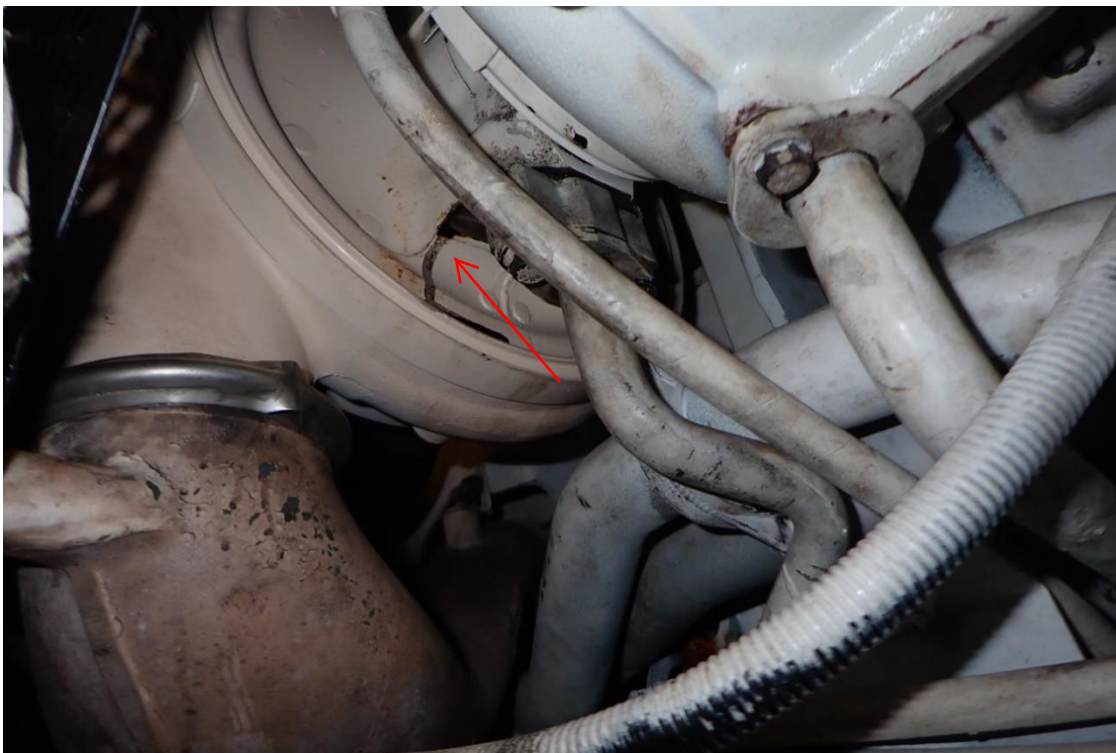
15. Apparent leak at starboard turbo

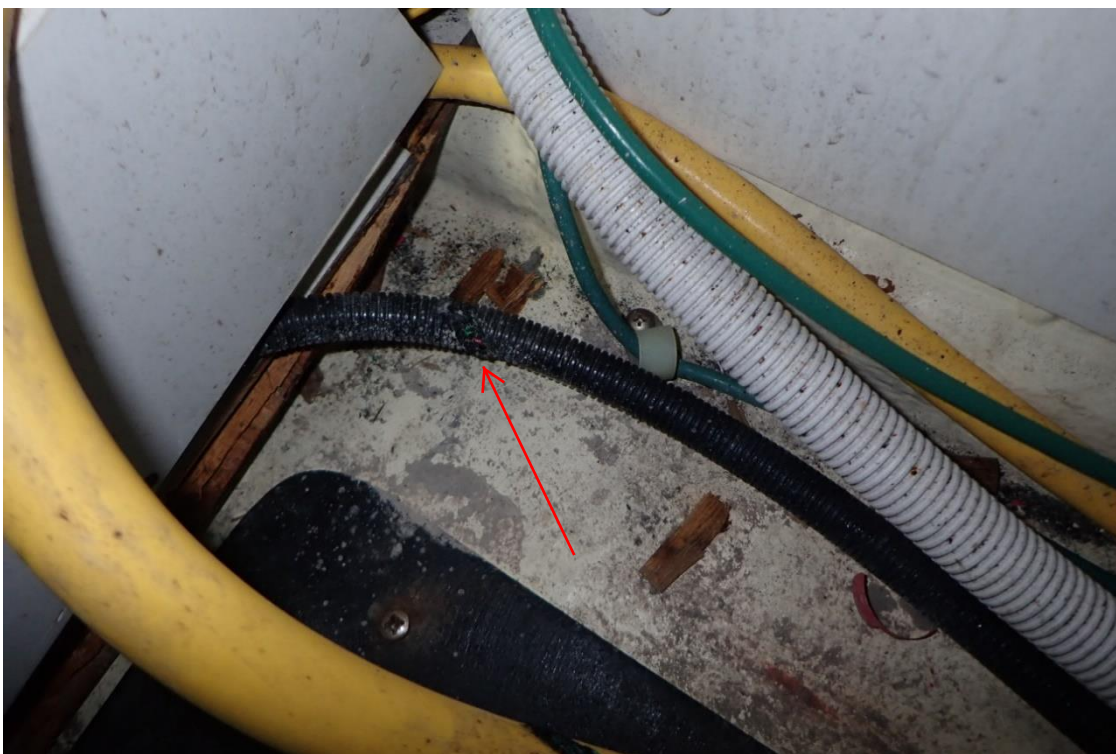
16. Overheating damage to wire loom, aft of starboard muffler

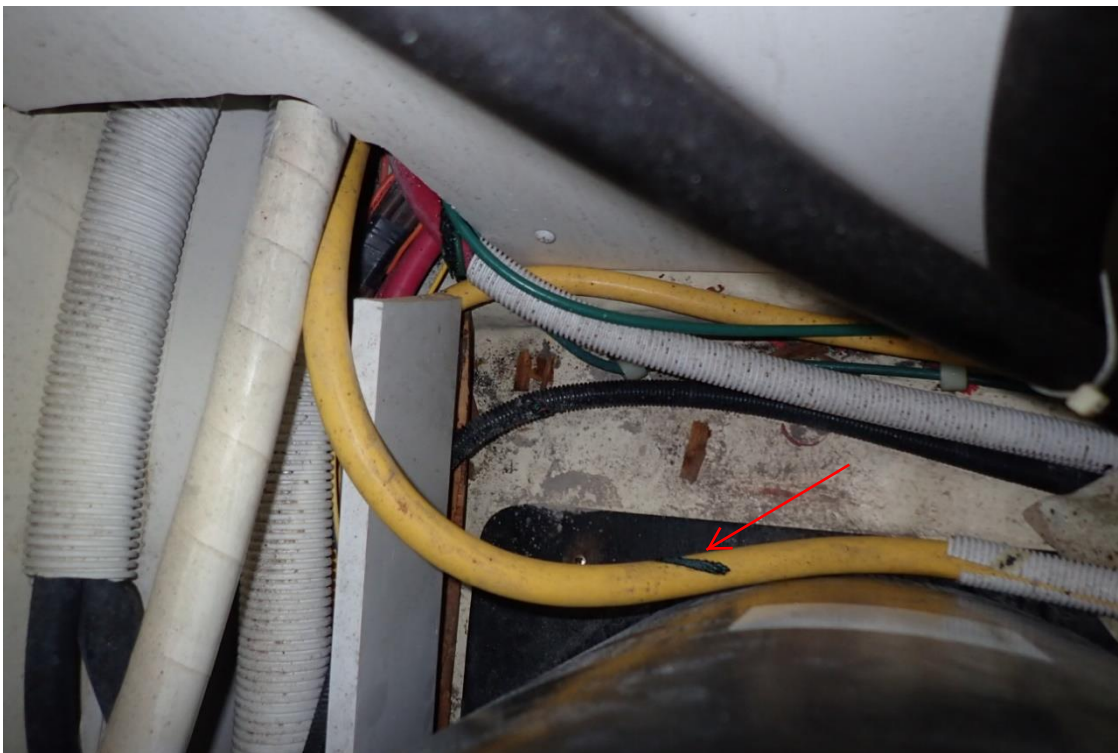
17. Overheating damage to battery cable, aft of starboard muffler

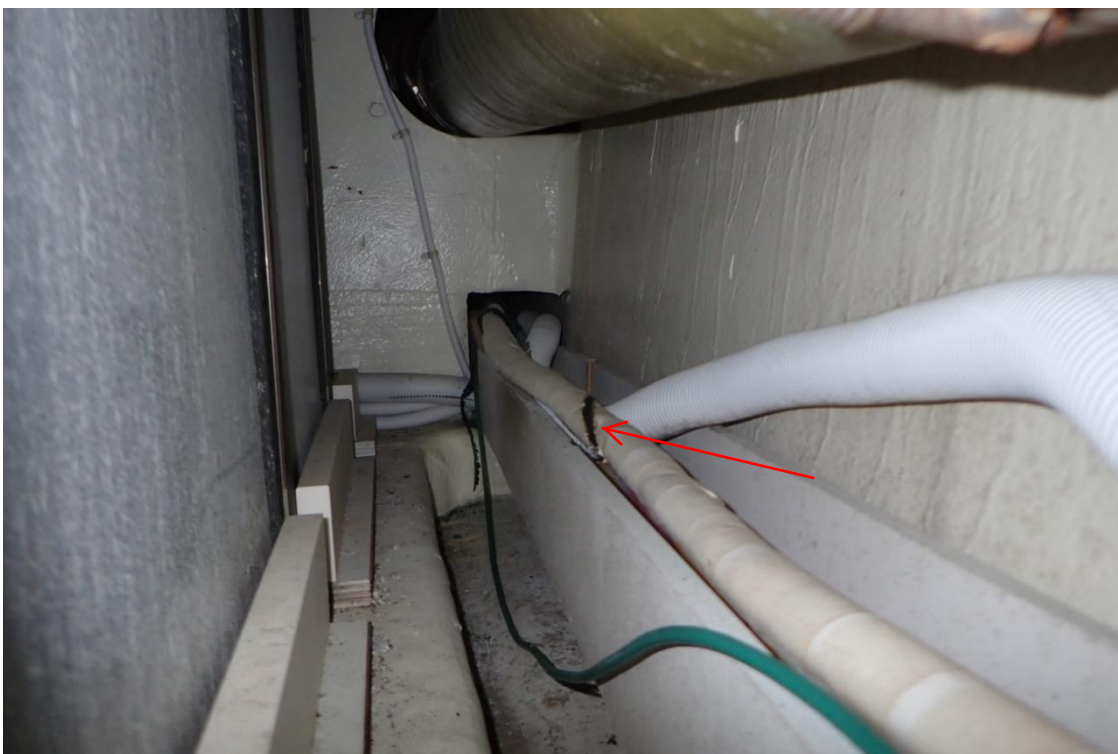
18. Overheating damage

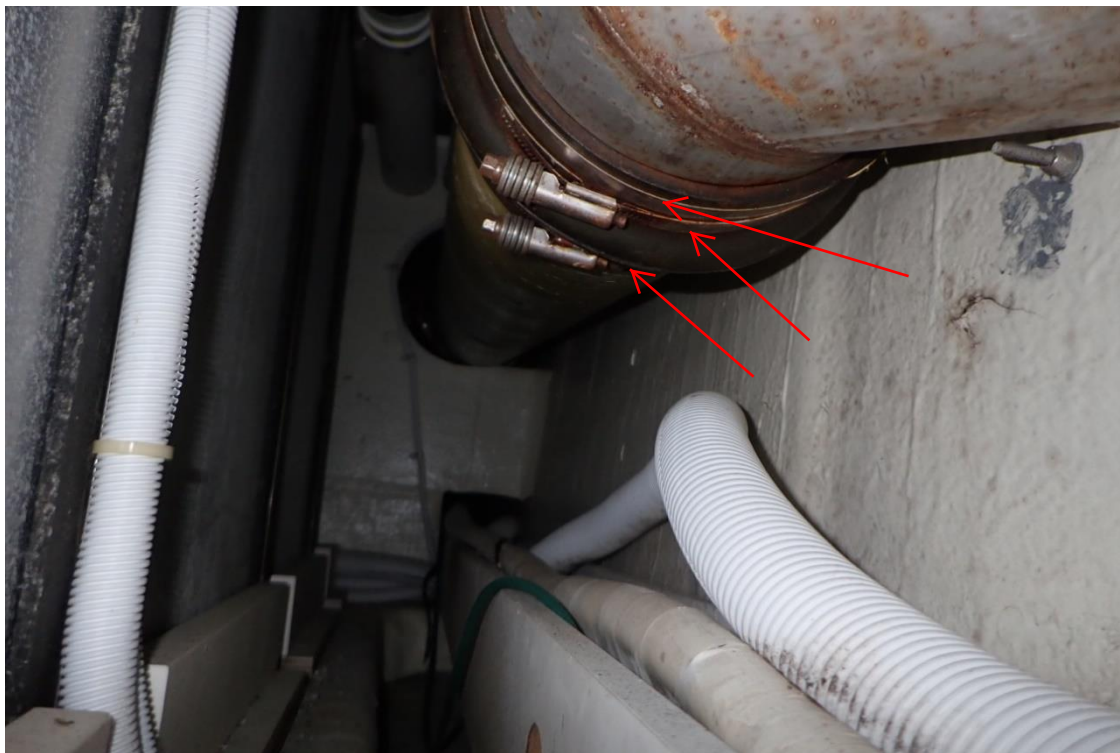
19. Corroding clamps at starboard exhaust thru-hull connections

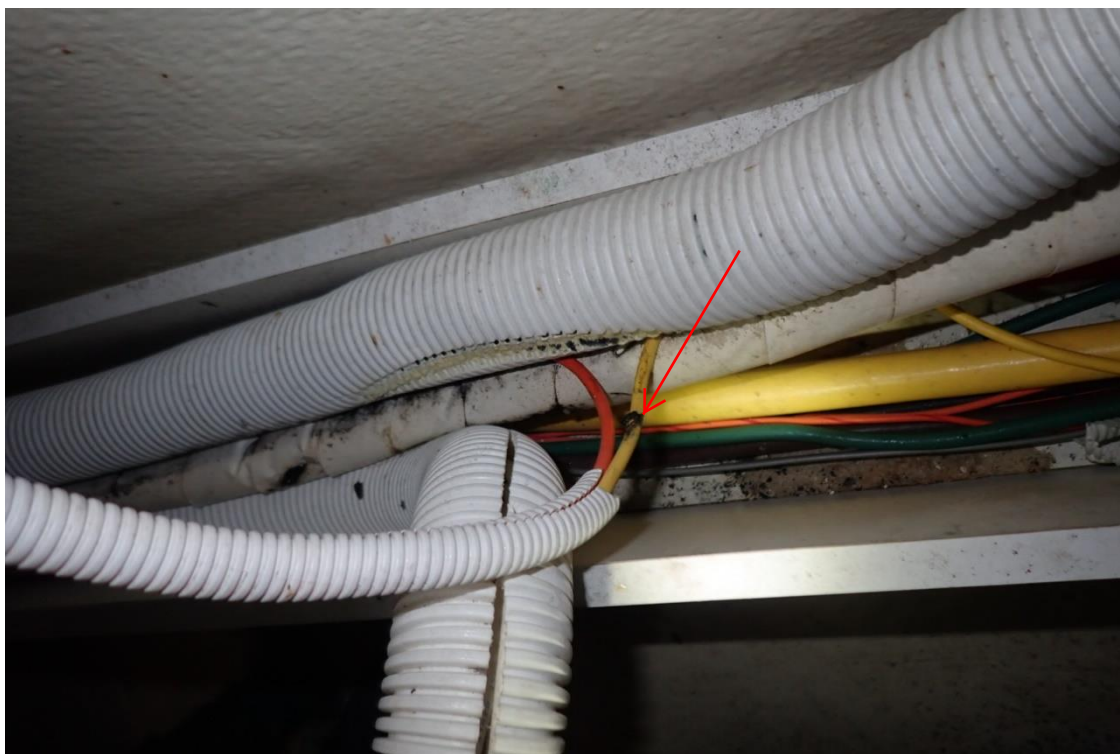
20. Overheating damage to wiring at starboard aft lazarette

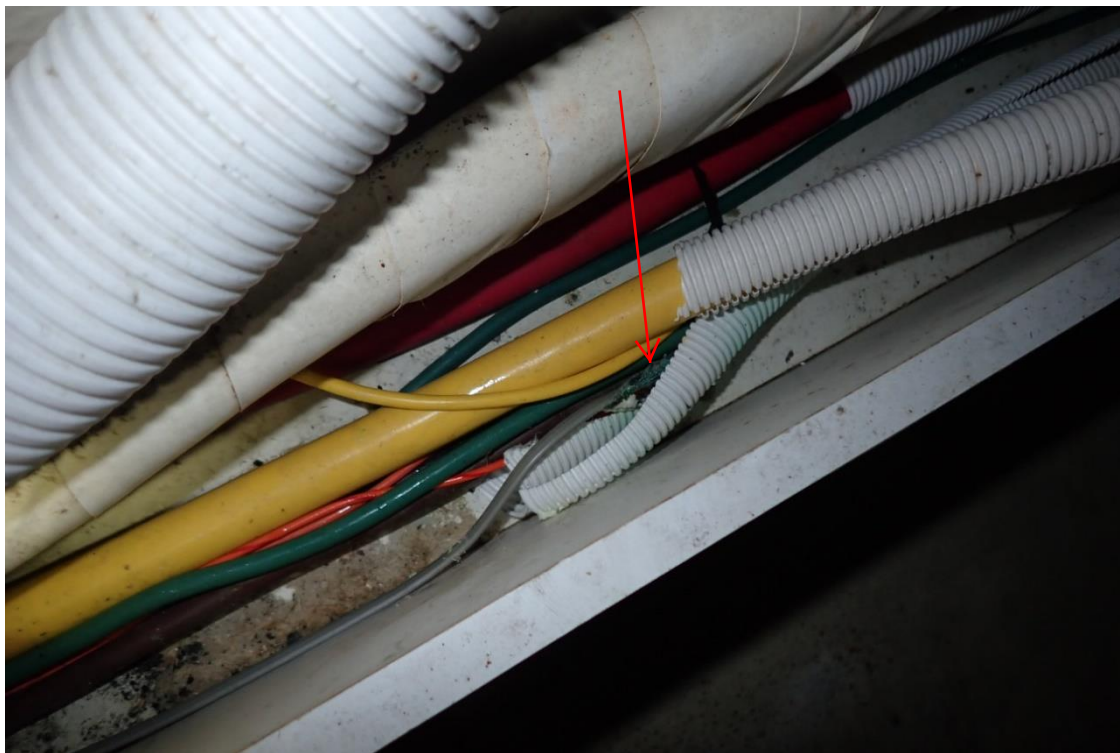
21. Overheating damage to wiring at starboard aft lazarette

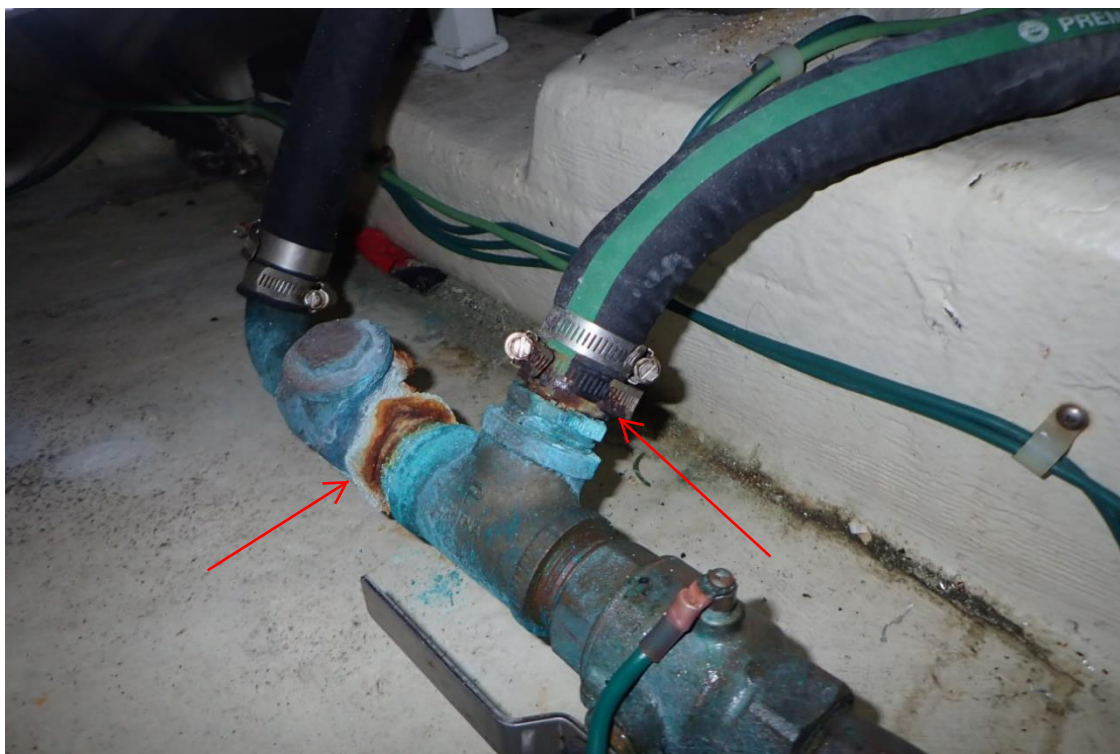
22. Broken clamp, corroded fittings, and leaks at air conditioner raw water intake

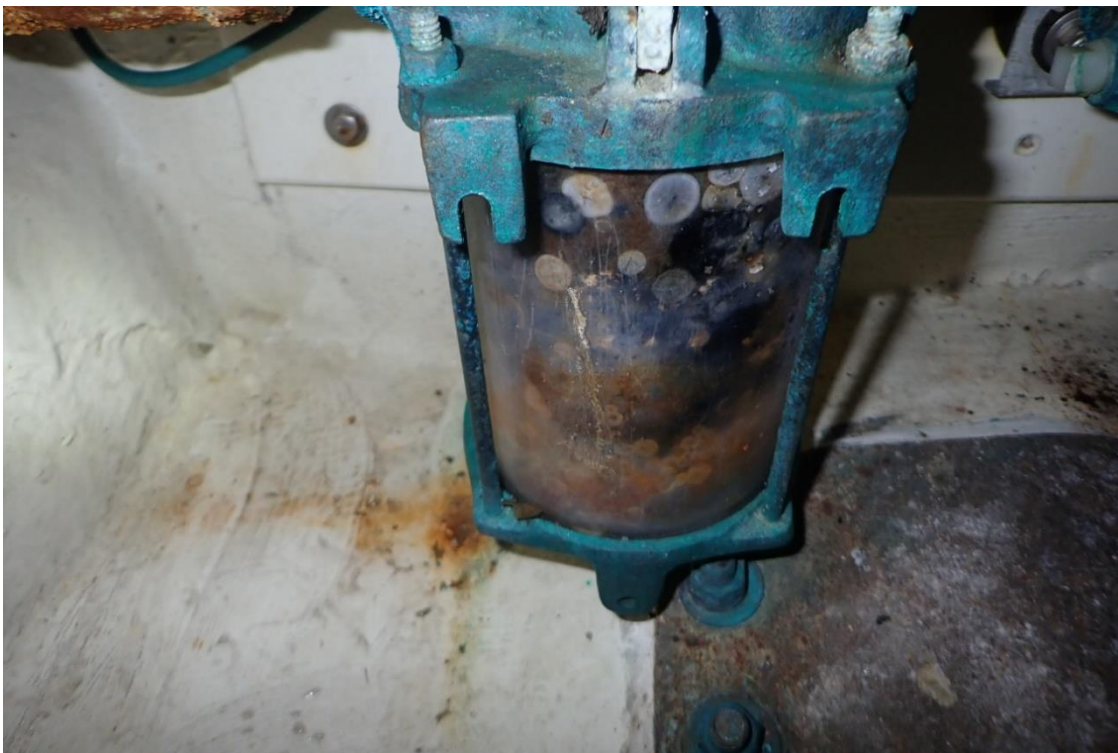
23. Air conditioner sea strainer fouled

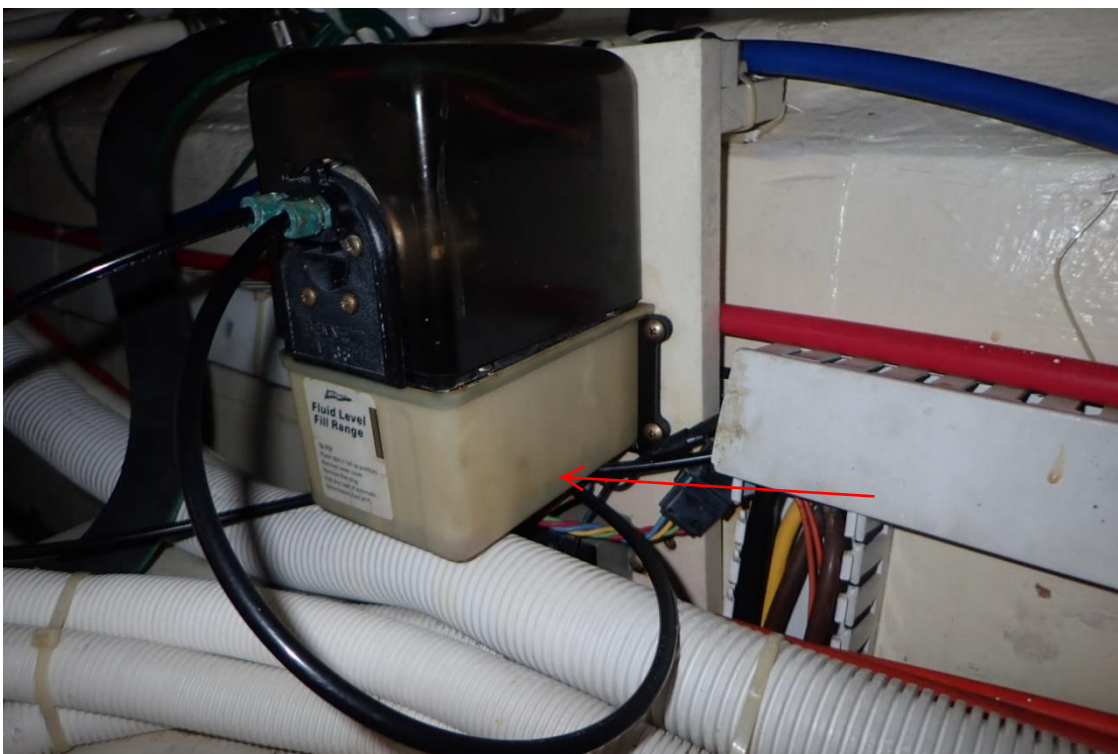
24. Trim tab fluid low

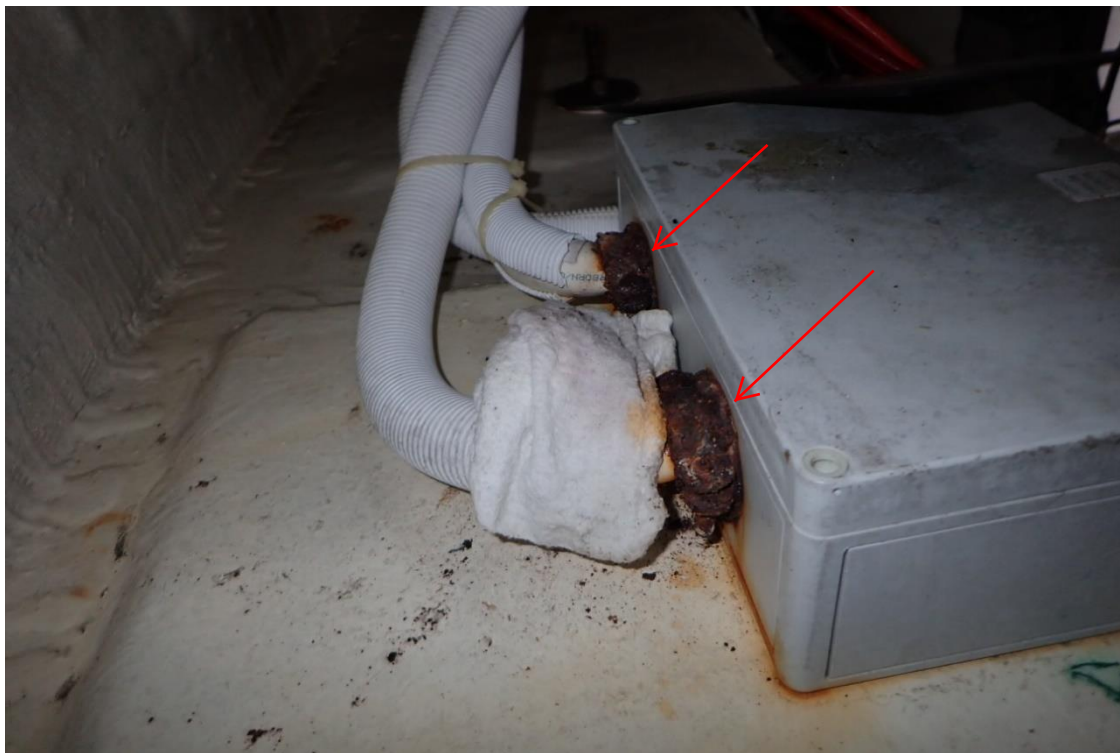
25. Corrosion at junction box in aft lazarette

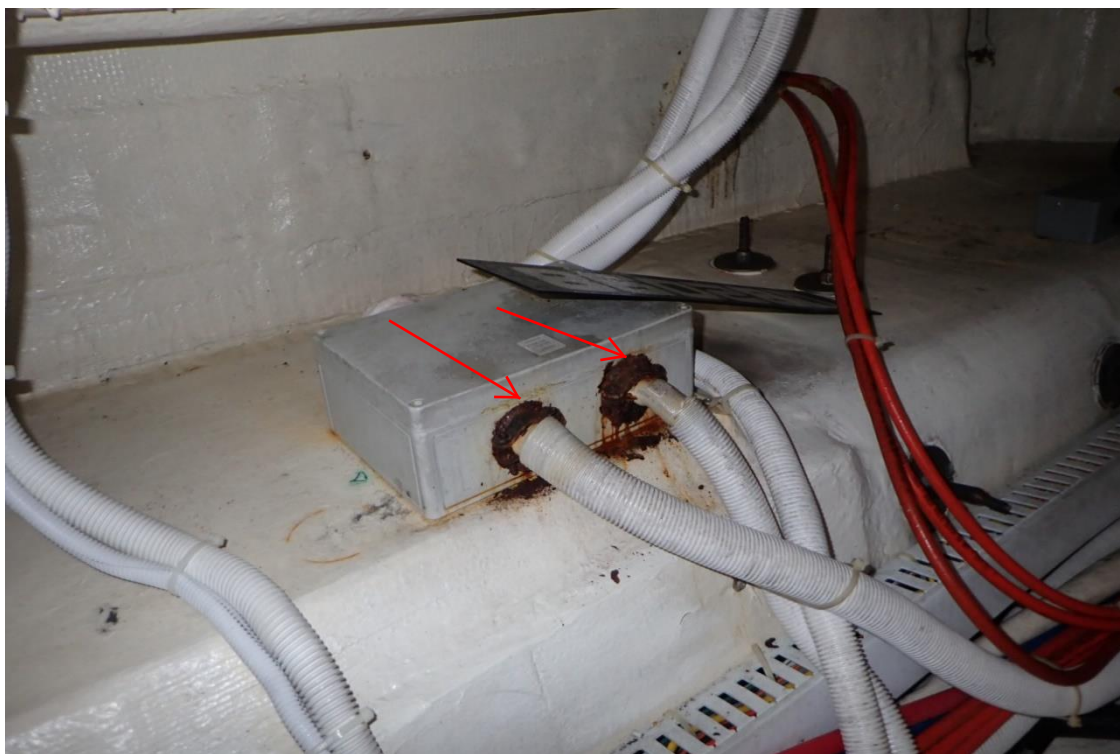
26. Corrosion at junction box in aft lazarette

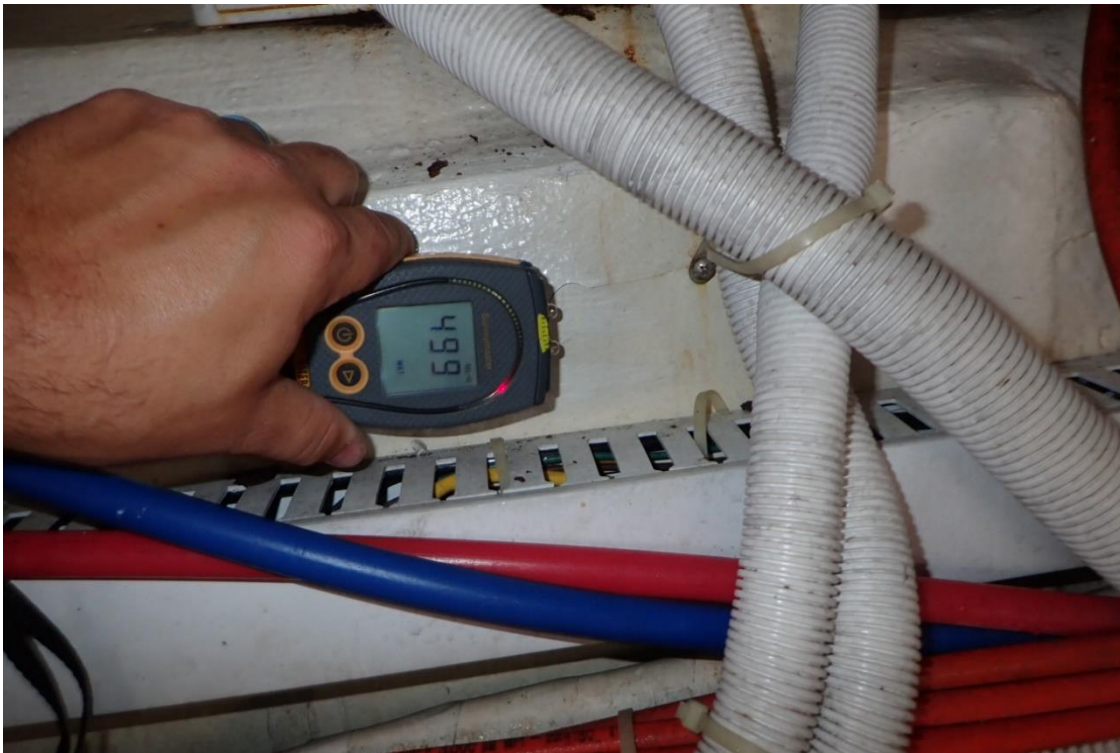
27. Wet moisture readings at inboard transom

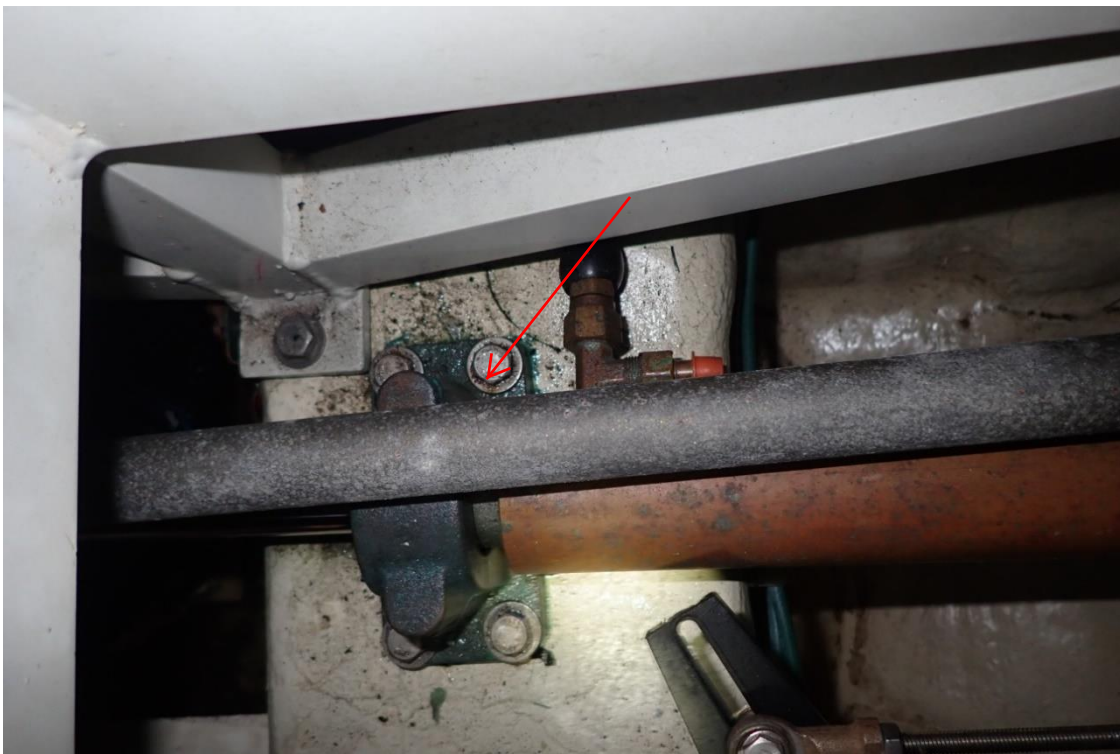
28. Steering fluid leak

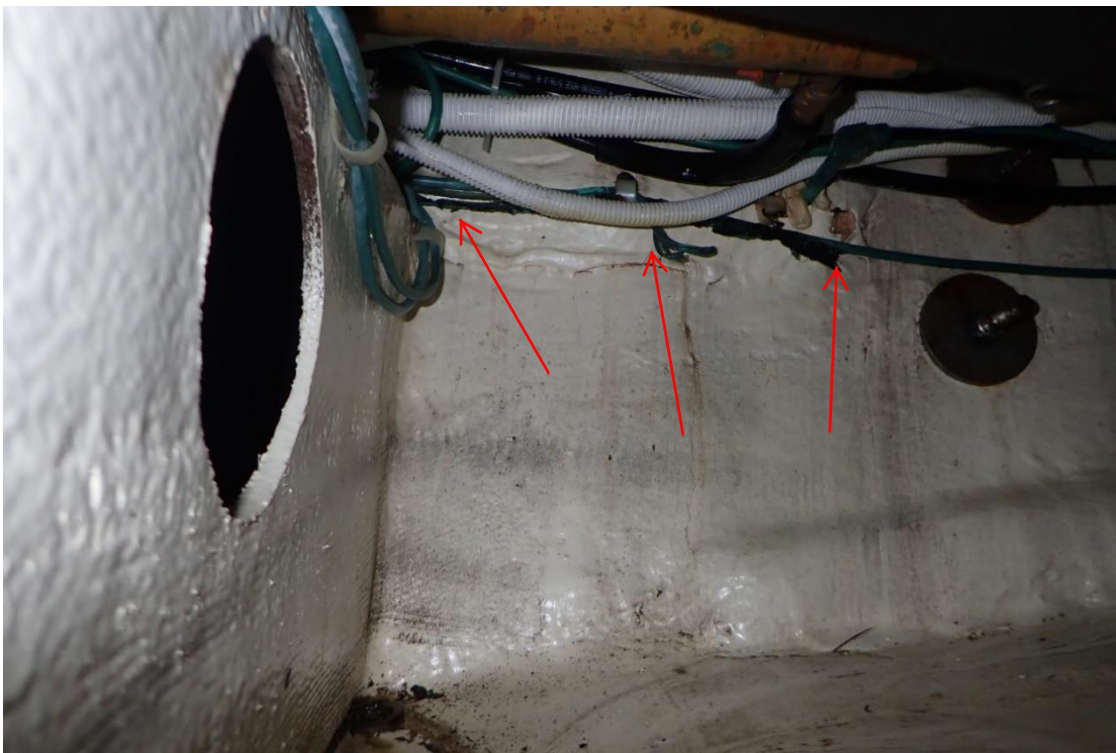
29. Damaged wiring from prior overheating

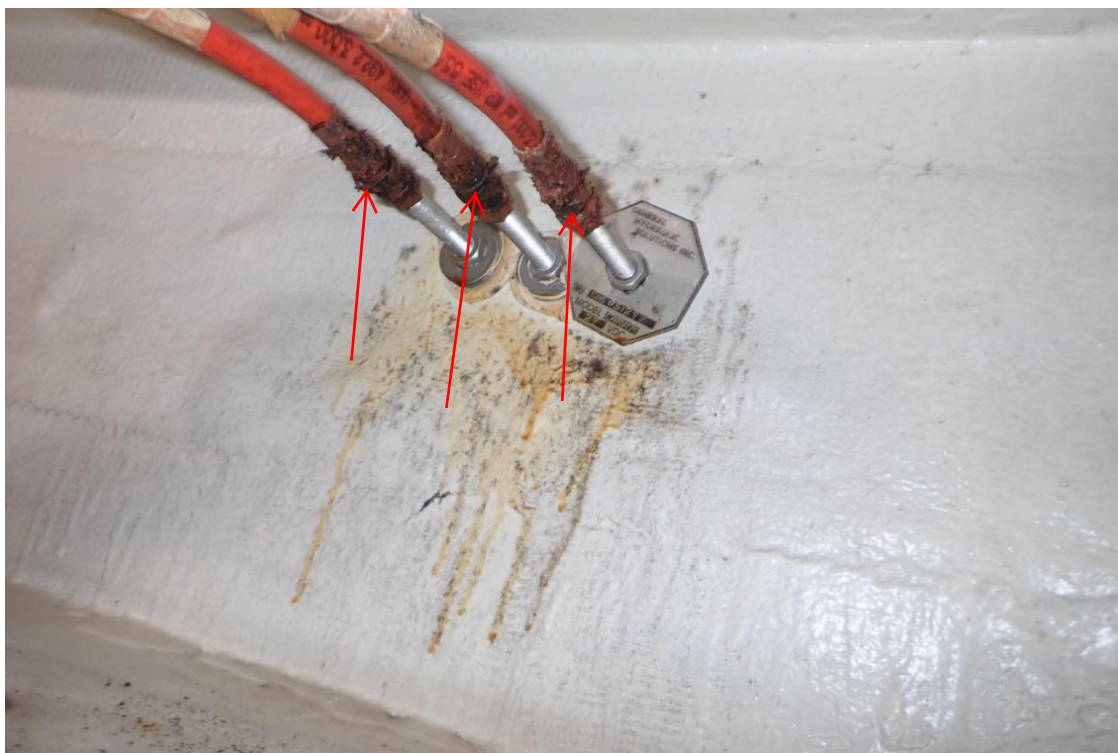
31. Swim platform hydraulic fittings corroding

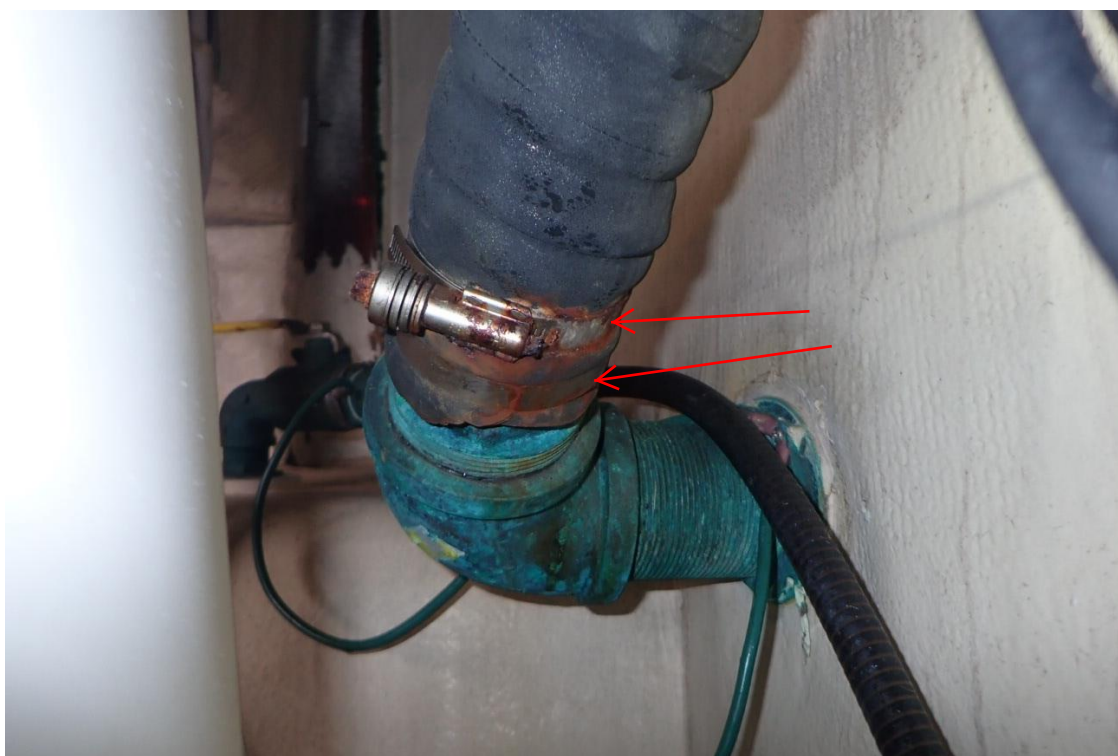
32. Broken and corroded clamps at generator exhaust in port lazarette

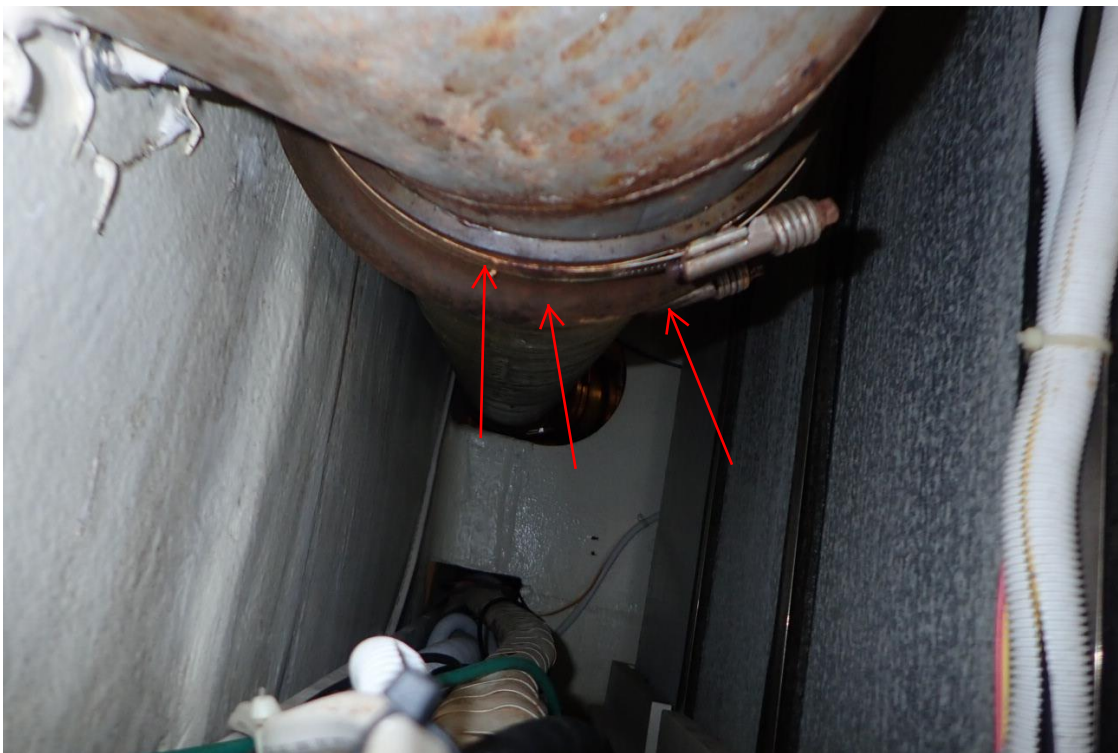
33. Corroded clamps at port exhaust fitting at port lazarette

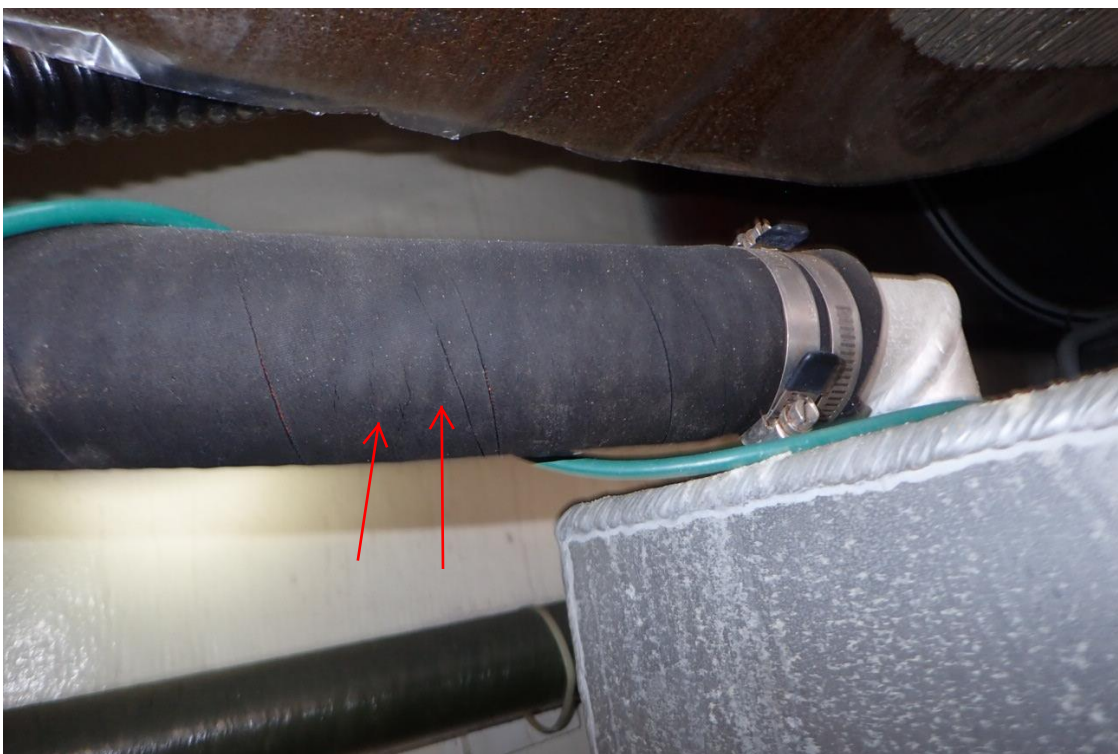
34. Fuel fill hose cracking

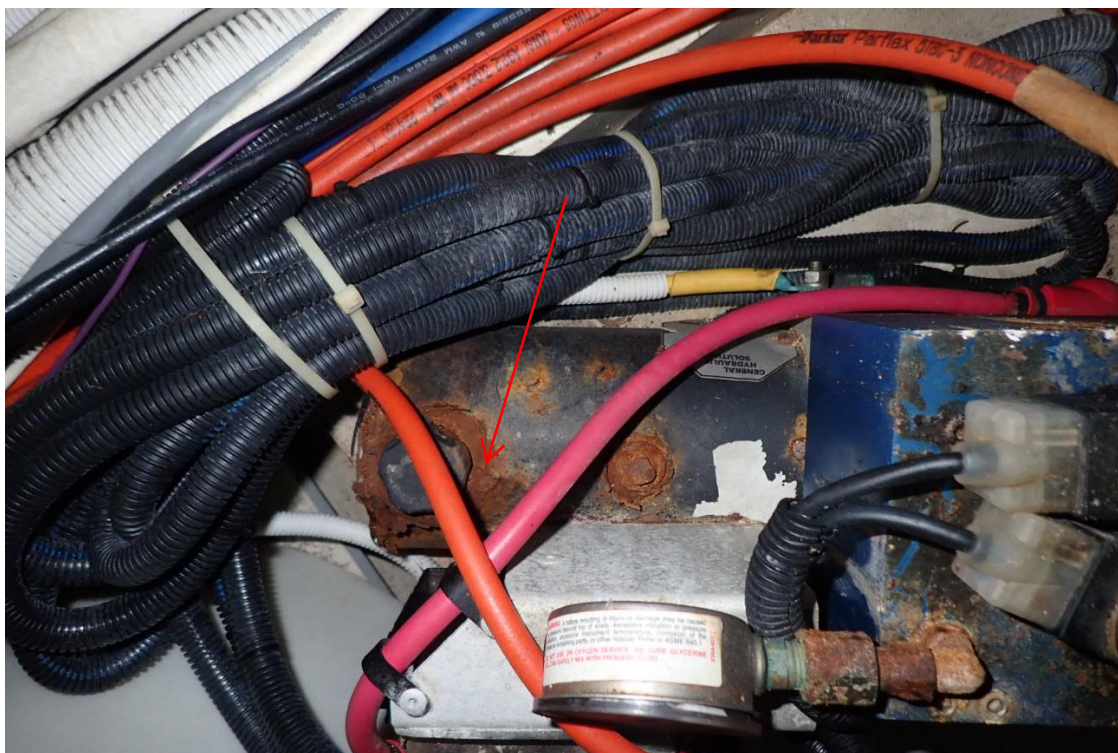
35. Corrosion at swim platform hydraulic pump

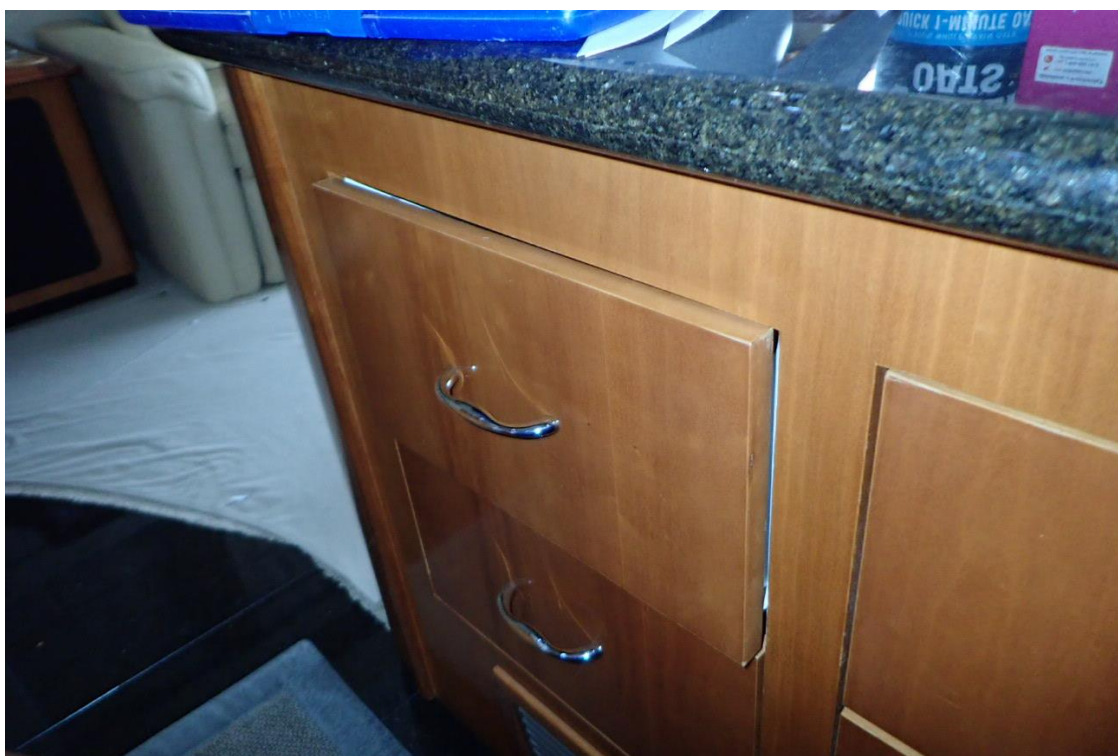
36. Galley drawer does not shut
