**2006 CARVER 56 VOYAGER  
PHOTOGRAPHS**

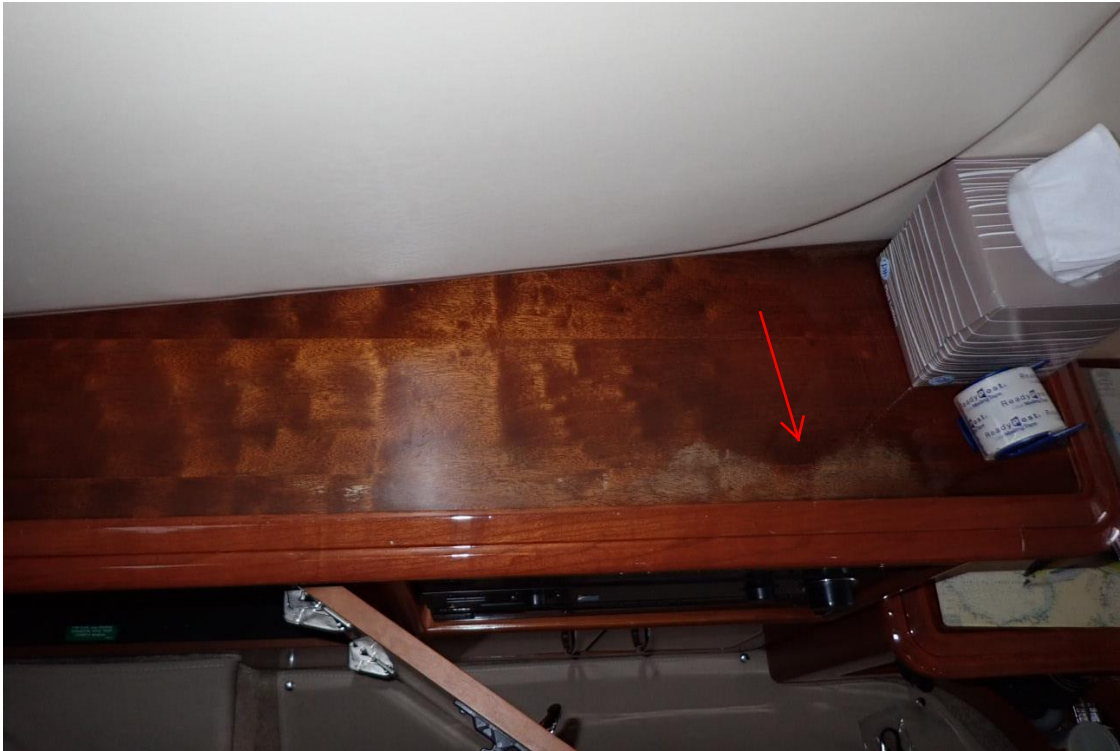
37. Wear/discoloration at brightwork/wood at starboard saloon

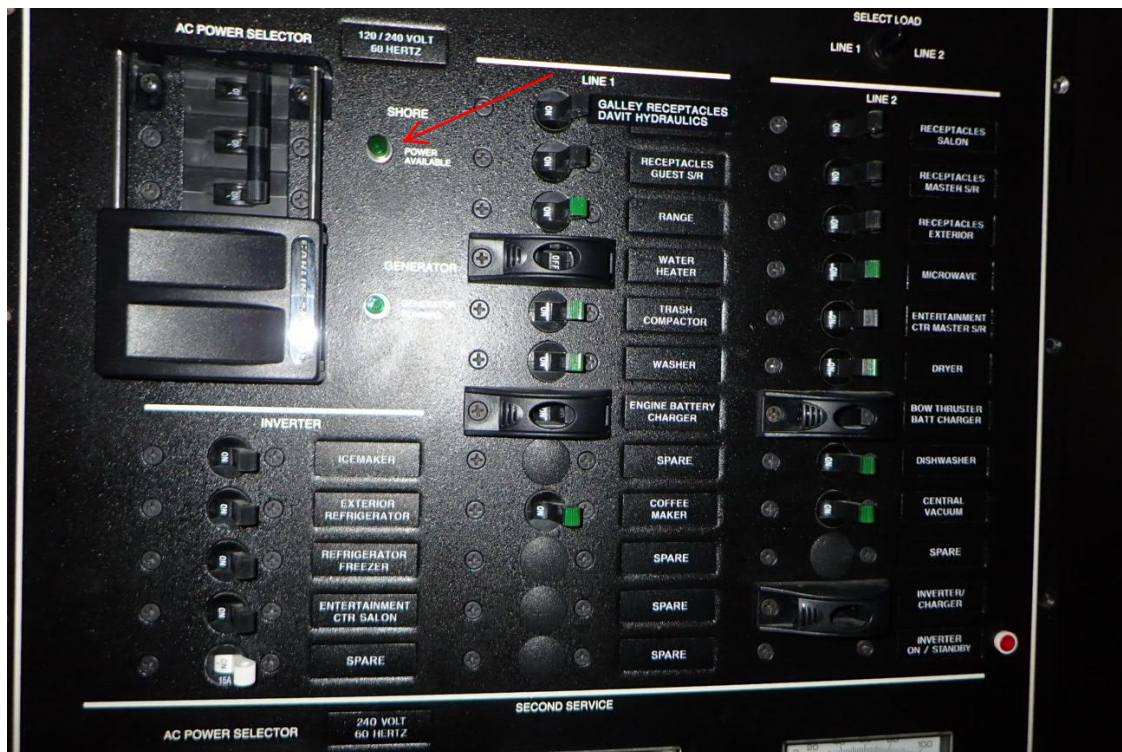
38. Power available light inoperable

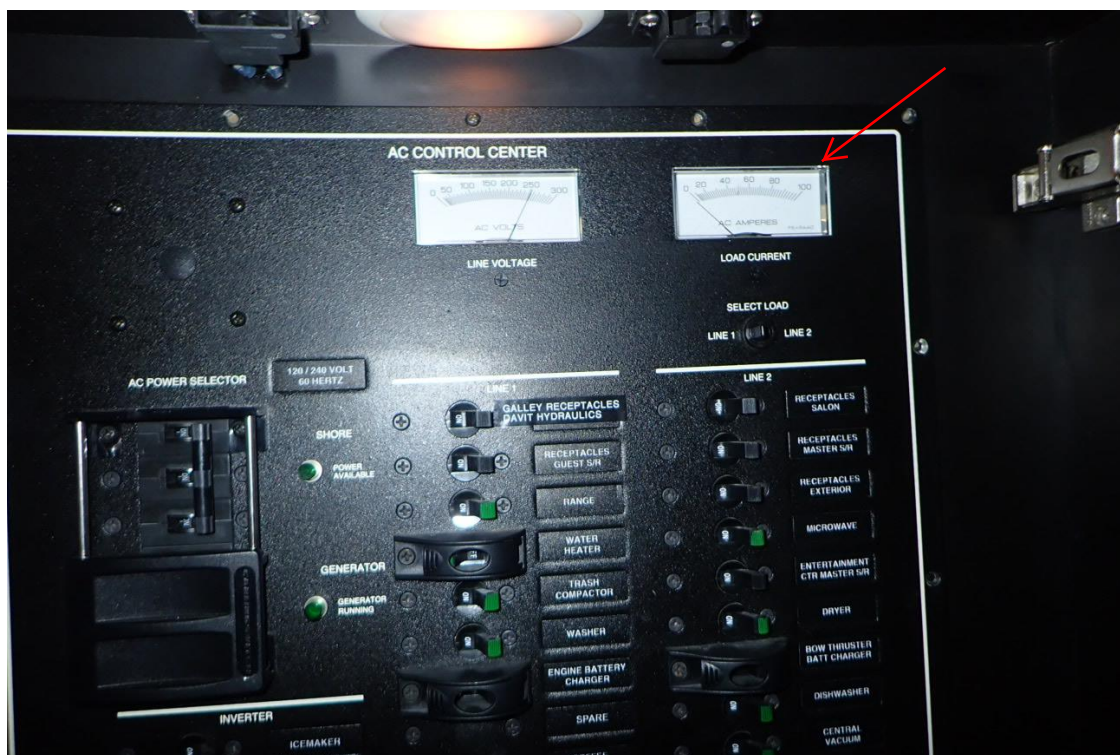
39. Ammeter not operable

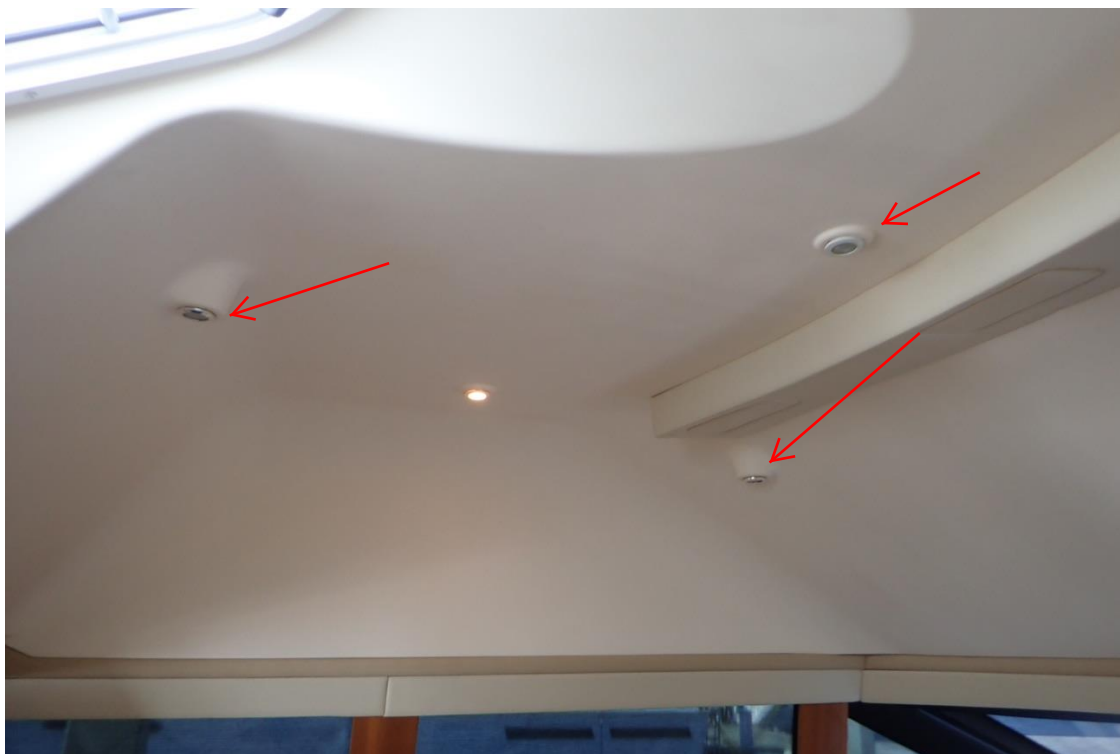
40. Lights inoperable at lounge

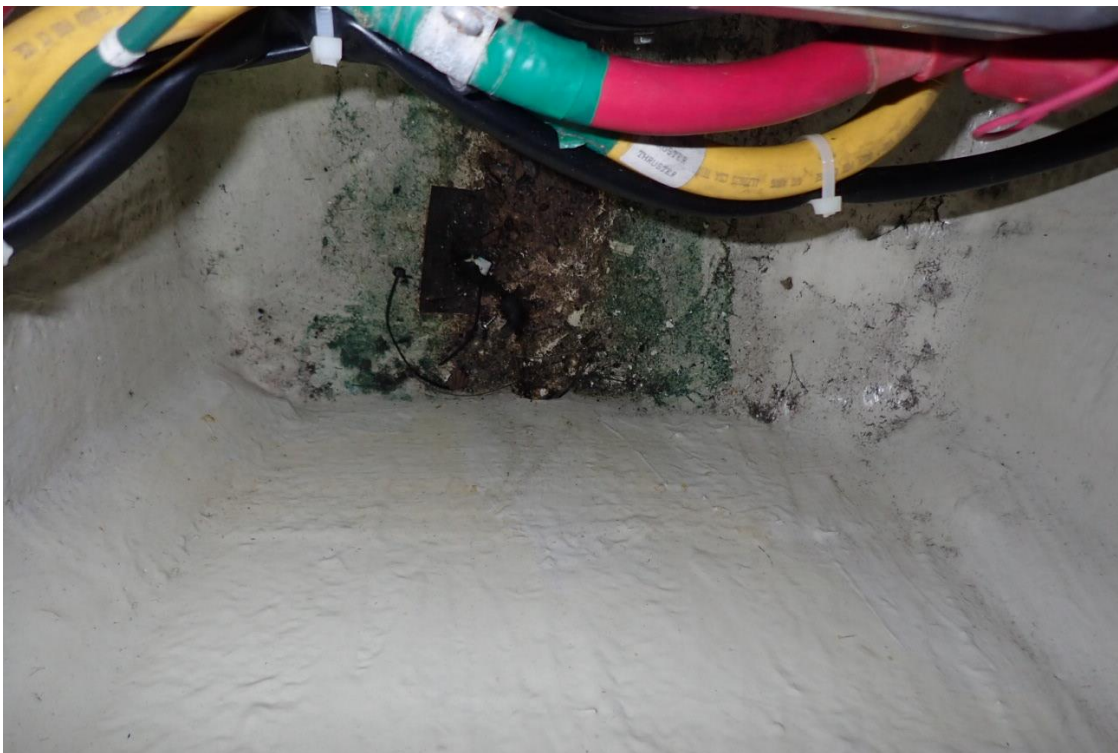
41. Debris in forward bilge

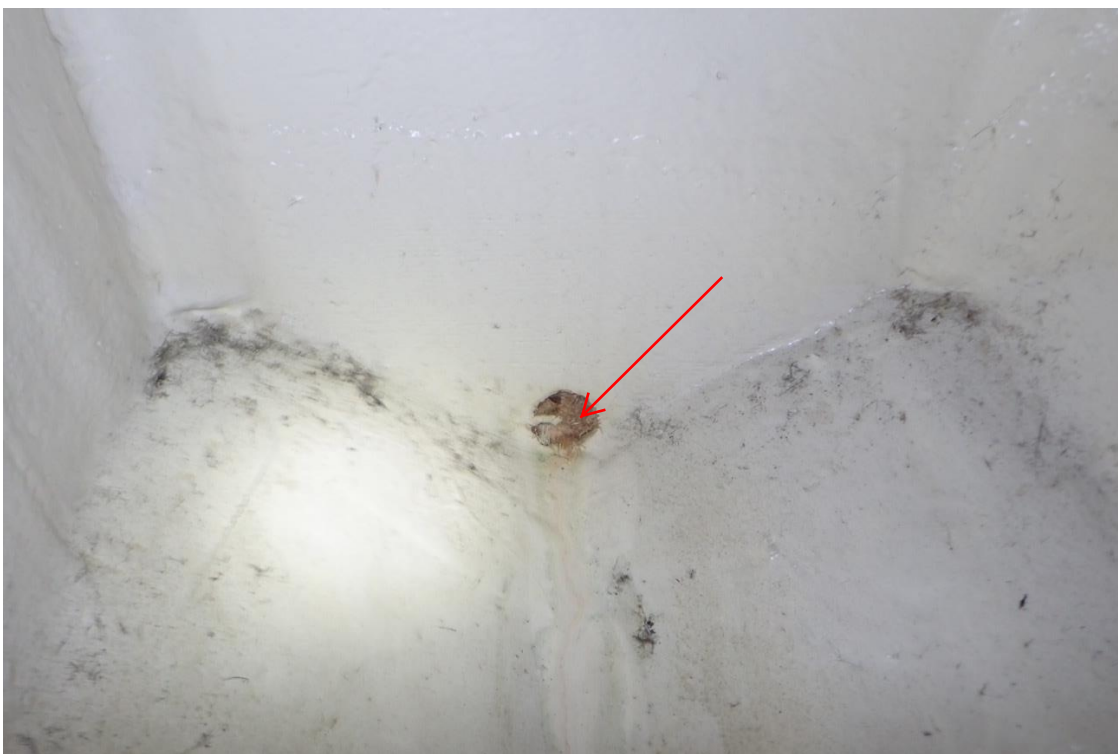
42. Forward limber hole fouled, centerline

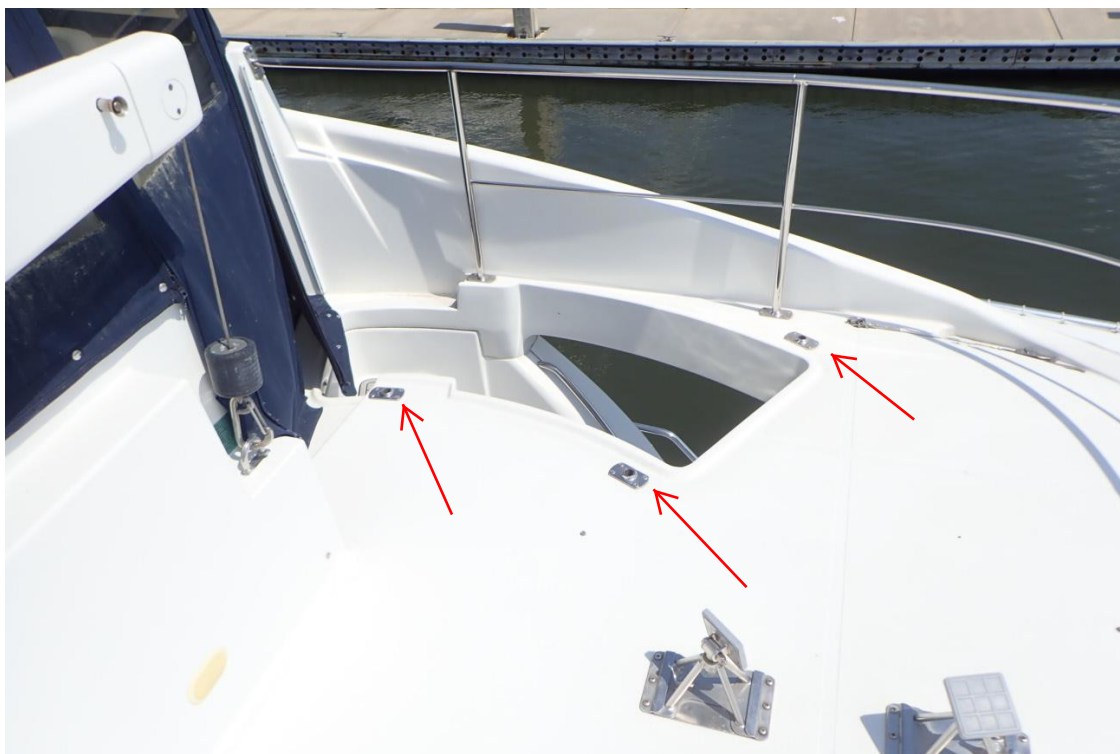
44. Aft sundeck railing removed at companionway

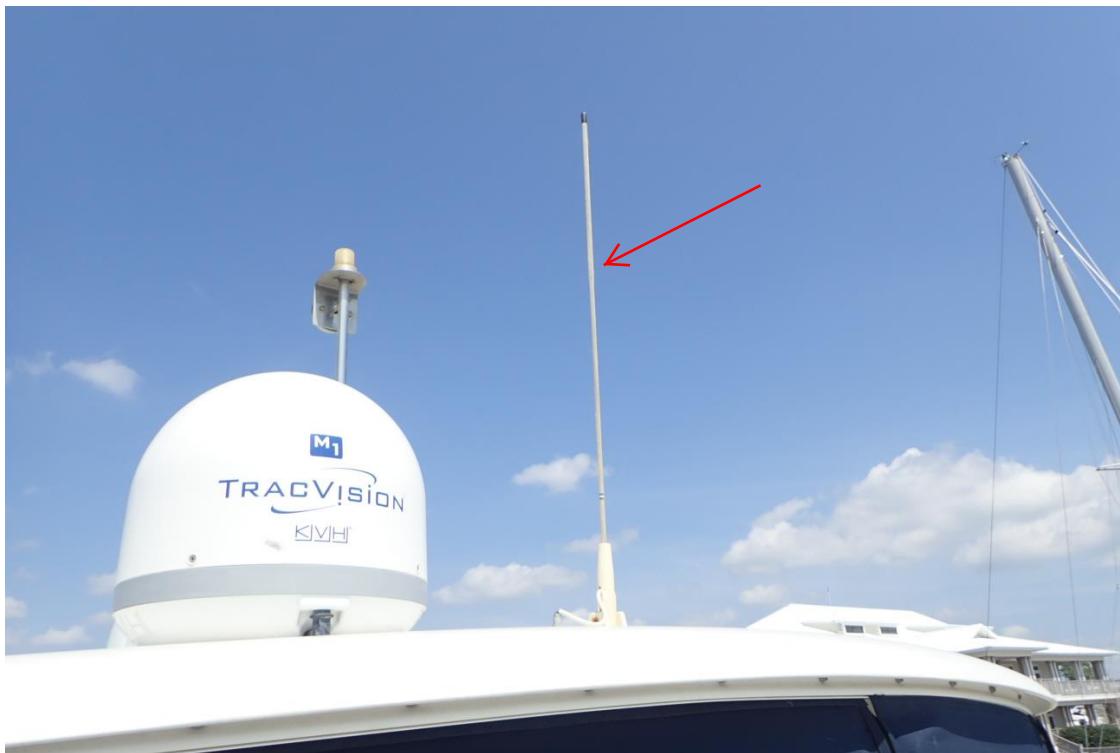
45. Antenna weathered and worn

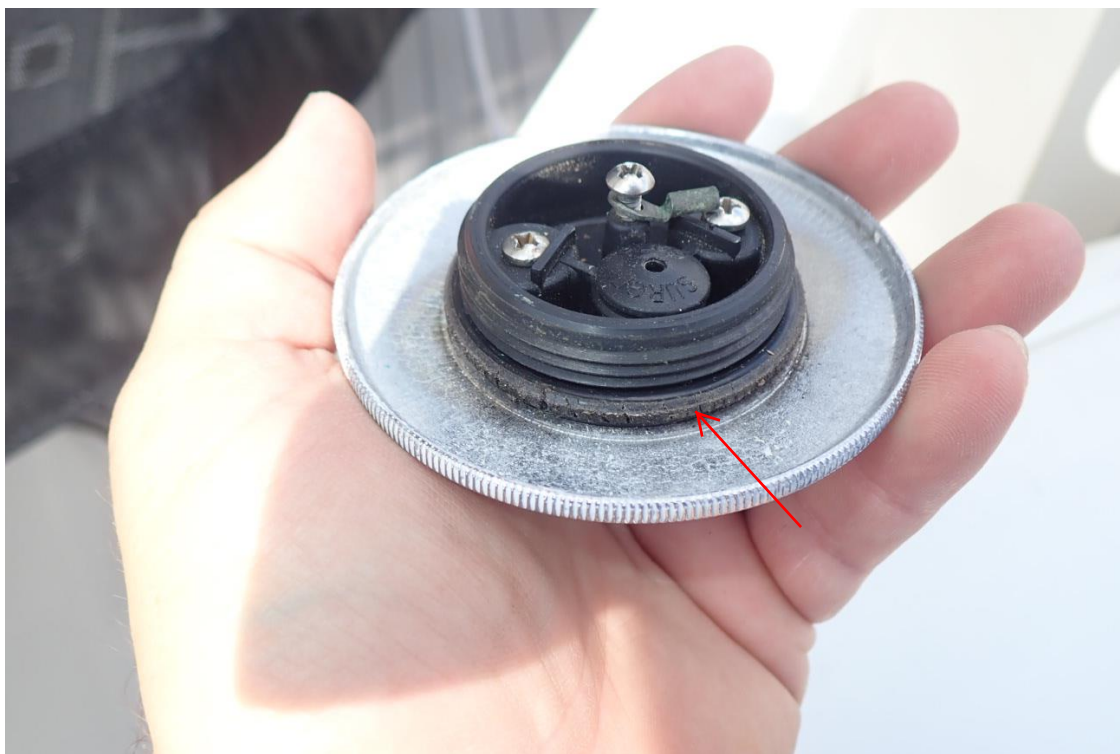
46. Fuel cap O-ring worn

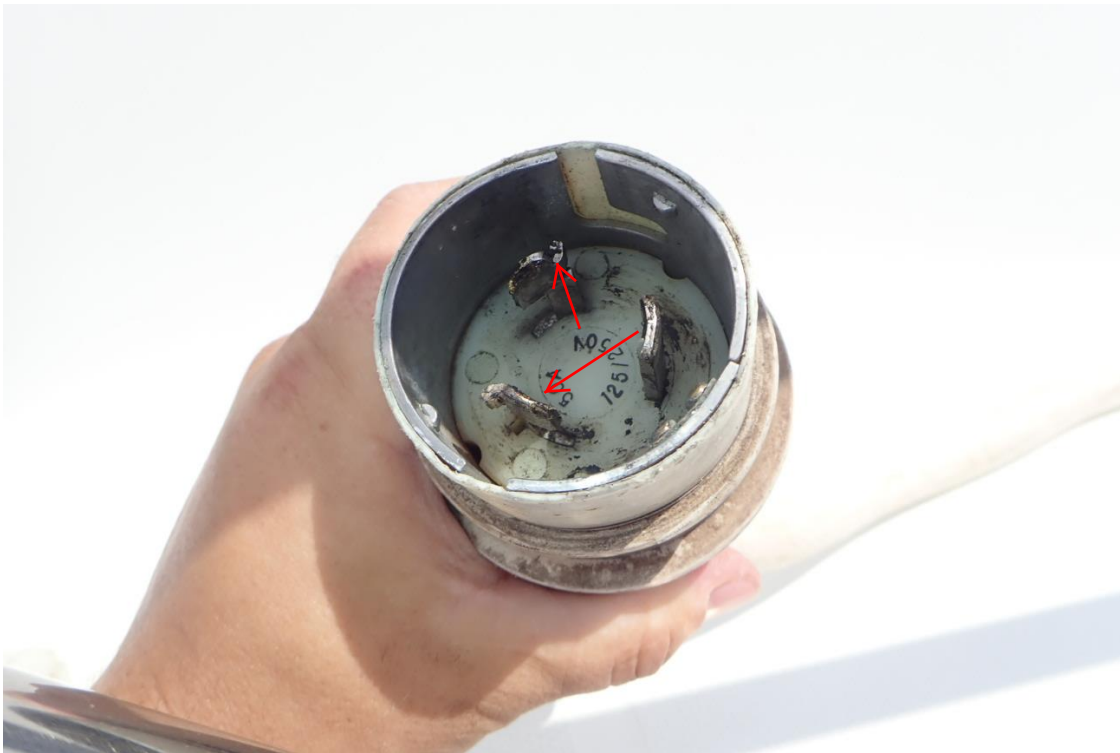
49. Arc damage to shore cable
