## **REPORT OF MARINE SURVEY**

### **INSURANCE EVALUATION**

“Lake Queen”

1996 Skipper Liner 62 Paddle Wheel

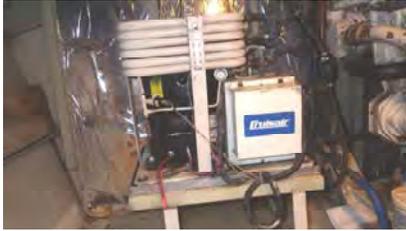
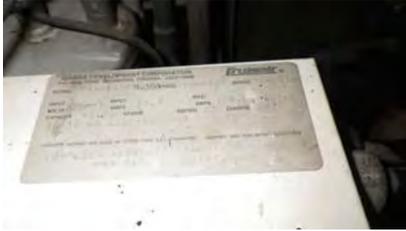
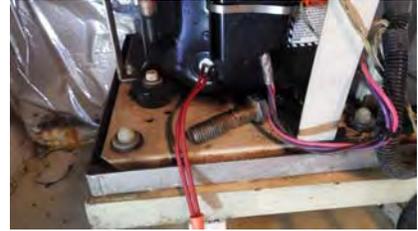
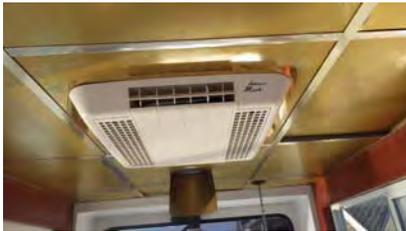
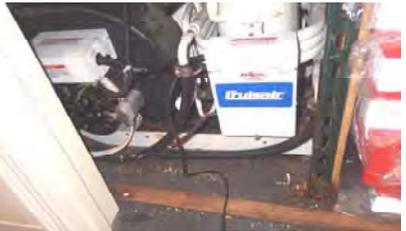
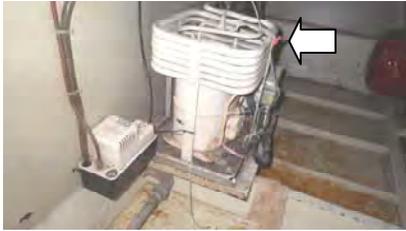
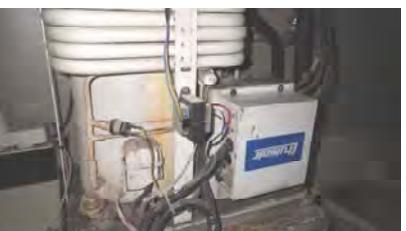
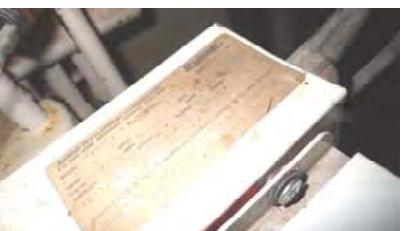
Start relay installed to forward hold unit. Sump is installed to evacuate condensate from tray hold unit, but engine space unit drains to the bilge adding to the condensation caused by the cold water of Lake Taneycomo. Bilge pumps are installed in the engine space to evacuate accumulated water from condensation and air conditioner.

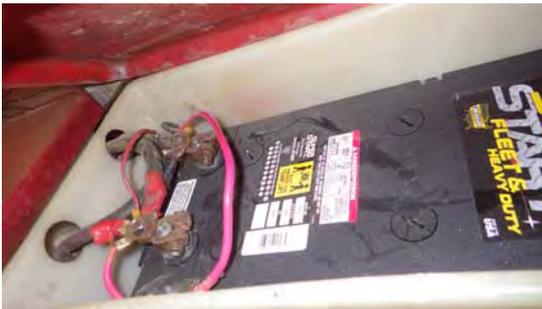
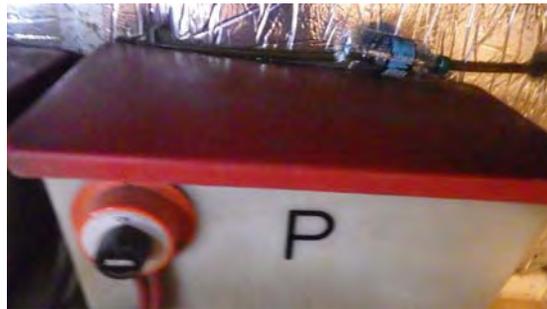
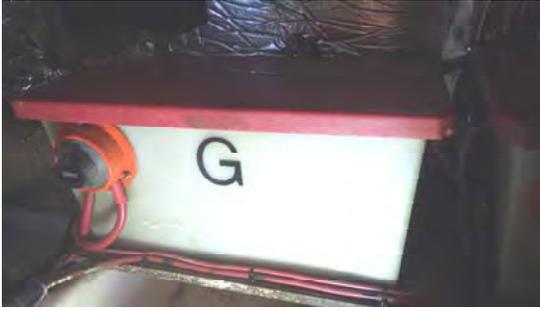
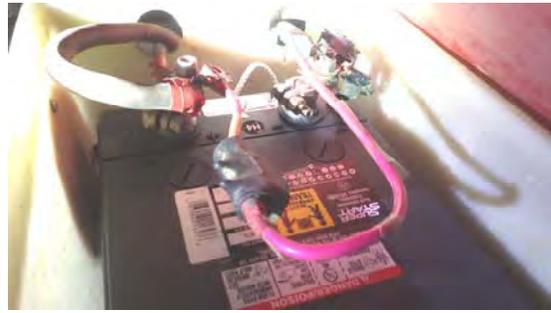
D.C. Voltage system:	12 Volt
Primary batteries:	Super Start St-4D3/1500 CCA 12v 2014 batteries each
Battery selector switch:	Yes on each Battery installed to the front of the individual boxes for each battery
Battery monitor:	None
Charging system:	Charles C-Charger 9000 series in cabinet six cells for Lead Acid only
Distribution panel:	Main DC inside electrical panel on aft lower deck.
Breaker(s) / fuse(s):	Breakers inside Square D panel
D.C. usage meter(s):	None
D.C. wiring:	Proper support and chafe protection observed. Terminals of positively charged conductors not insulated from accidental arcing.
D.C. Electrical ground:	Three Conductors grounded to hull's stringer.
12 volt outlet(s):	None
Conductor identification:	No
Standards Remarks:	Given scope of electrical details involving the relation between AC and DC connections, recommend adherence to 33 CFR 183.400 supart I for corrective repairs as required for both AC & DC systems.

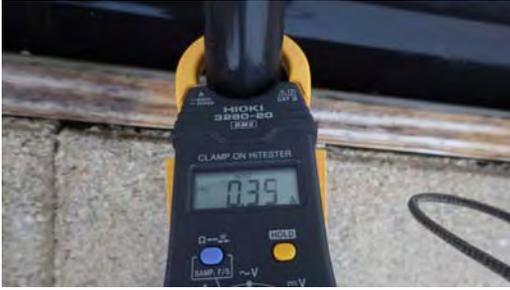
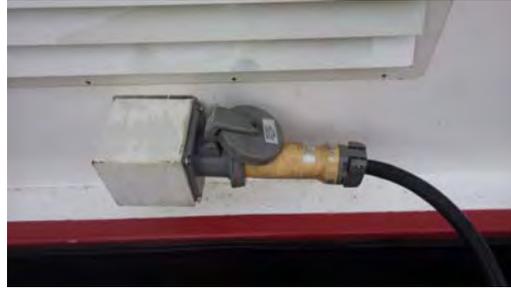
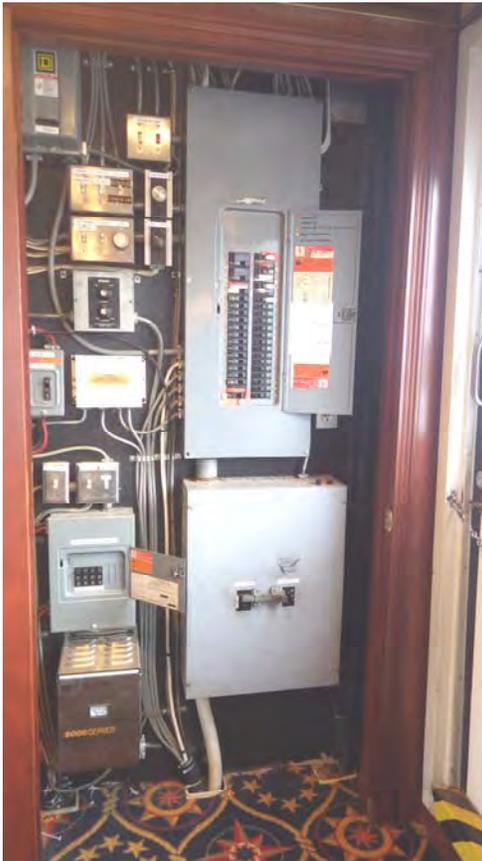
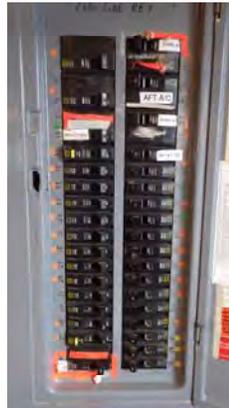
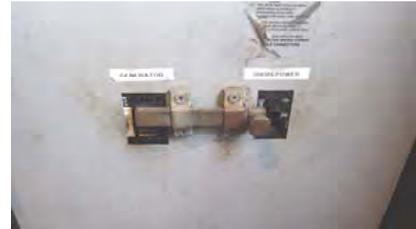
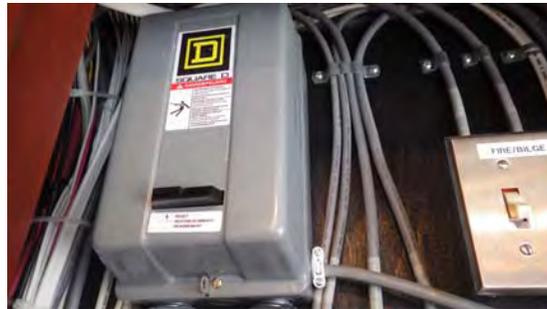
The inspection of the vessel identified an AC (alternating current) issue with .35 amps imbalance at the shore cord. Active troubleshooting during the course of the survey eliminated conditions with the inverter receptacle in the pilot house and two air conditioners. Issue was determined by Electrician to be high resistance connections and corrected at the time of survey and the day after by the electrician. An Air Conditioner technician additionally inspected the air conditioners for fault correct termination issues reportedly. At this time, the issue is reportedly corrected.

1. Electrical on the vessel found fault with improper grounding conductor AC to DC imbalance. Corrected at time of inspection found fault with high resistance terminations on shore plug, pilot house receptacle and two Air conditioners. **CORRECTED**
2. Navigation stern light inoperative at inspection. **CORRECTED**
3. Galley GFCI receptacle inoperative on manual test. Renewed during inspection and tested operational. **CORRECTED**
4. Bar Receptacle shorted and burned. Renewed during inspection and retested. **CORRECTED.**
5. Fuel Shut-off valve aft fitting is leaking diesel fuel. Secure leak and renew drip pads to identify future leaks.

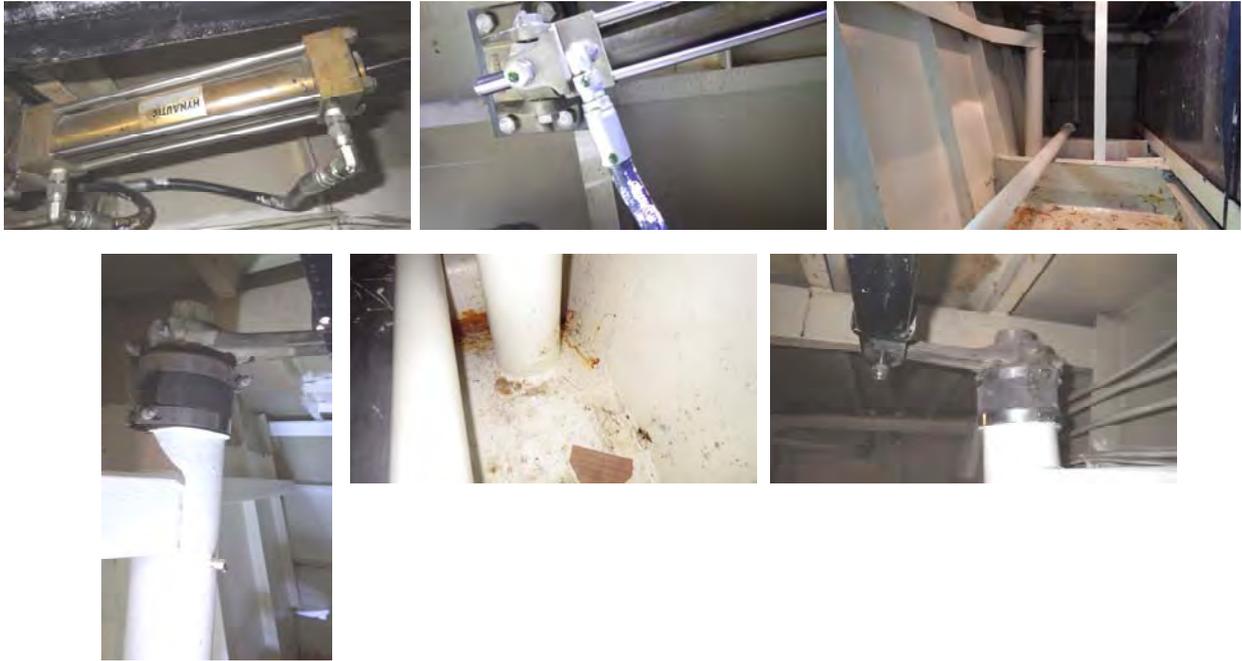
Mounting(s):	Secure - Nylock
Rudder stock(s):	Good
Steering tie bar:	Good
Packing glands:	Good – Stand pipes above water line with double clamped packings
Steering Remarks:	Correction of leaks to actuator recommended.

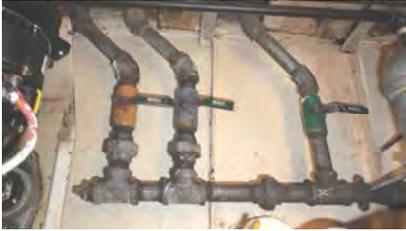
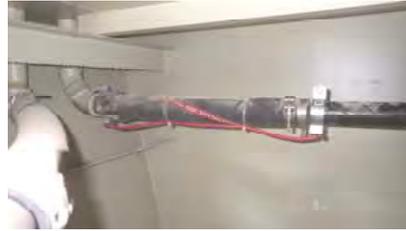
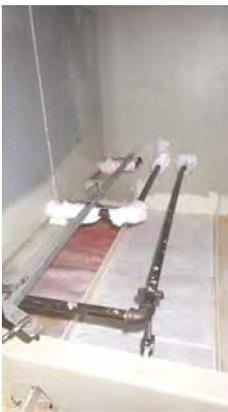
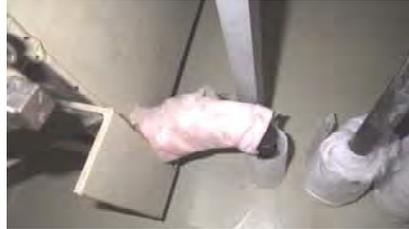
No & Location:	Bilge compartment #2
Tank type & capacity:	Steel – Capacity by measurement only as no labels in place. (24x40x96 inches) yields 398 gallons approximately
Manufacturer’s label(s):	None
Fuel supply lines:	Pipe – leak at aft fitting with drip pads under confirming leak
Diesel return line(s):	None
Shut off valve(s):	Yes. Single pull cable to all three on tie bar installation
Vent line / location:	Next to fill
Fill line(s) located:	Above the sheer adjacent to fill inlets
Fill pipe and condition:	Good

Screw type clamp securing ground cable to pipe of inlet hose at flex joint.
