REPORT OF MARINE SURVEY

INSURANCE EVALUATION

“Landing Princess”
2007 Skipper Liner 96’ MY Series 1017

CONDUCTED BY:
Michael Hunter, NAMS-CMS, SAMS-AMS
On
August 11, 2015

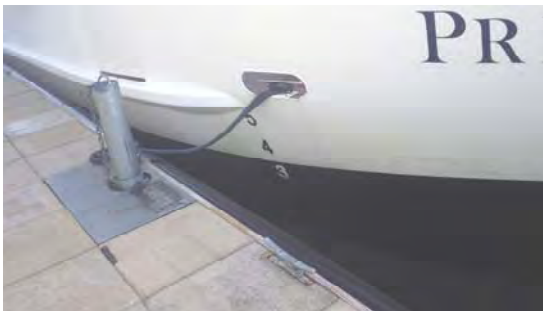
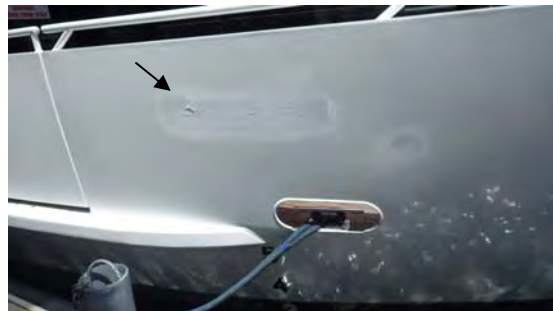
Construction material	Steel
Hull cosmetics:	Excellent, minor dock indentations of a non-structural nature at dock level
Moisture / Delamination:	None – not applicable
Side thru hull fittings:	Not accessible externally
Engine room vents:	Properly situated port and starboard hull sides with mechanical shut-off

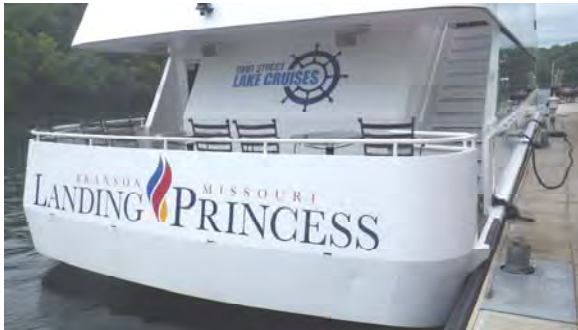
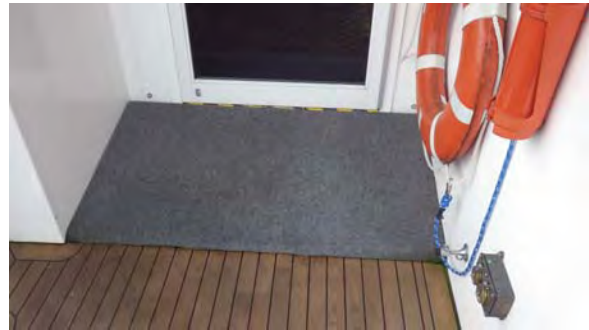
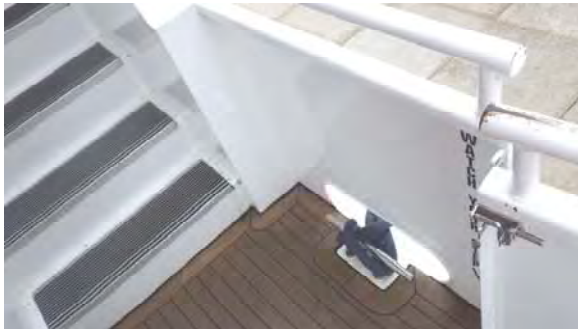
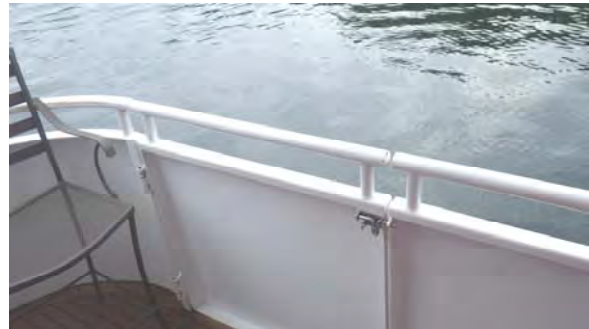
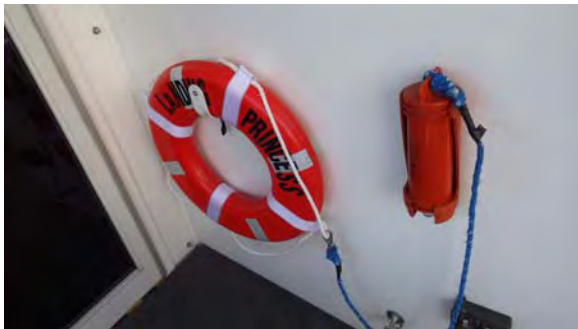
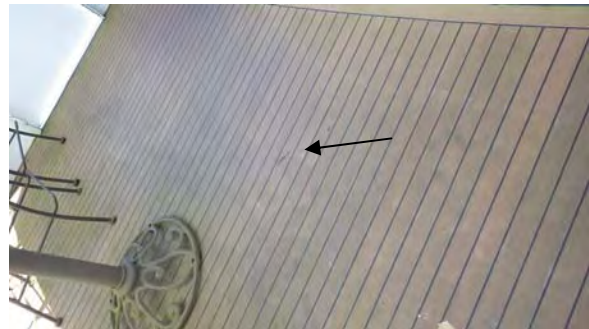
Boarding location of vessel port and starboard aft deck. *Ramp for access through port side door has two inch trip hazard at interior ramp.*

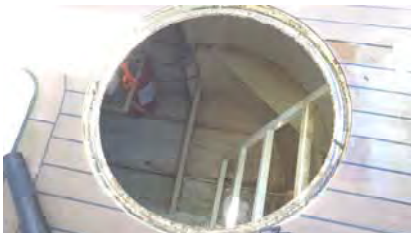
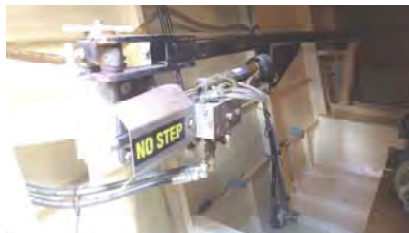
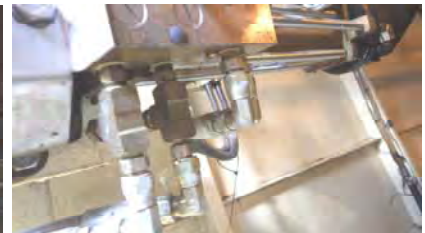
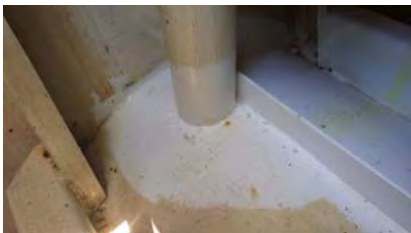
Lazarette reveals extensive amounts of hydraulic fluid leaks to steering actuator and rusting of welds. Water lines observed.

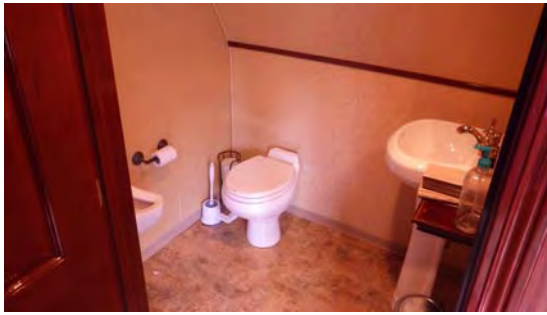
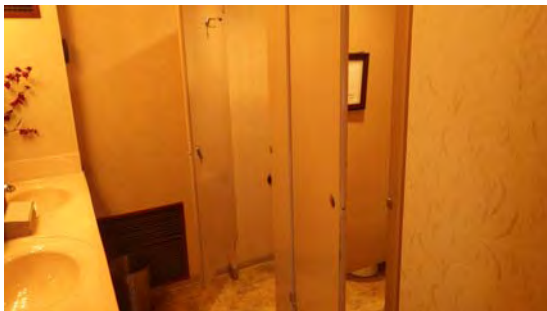
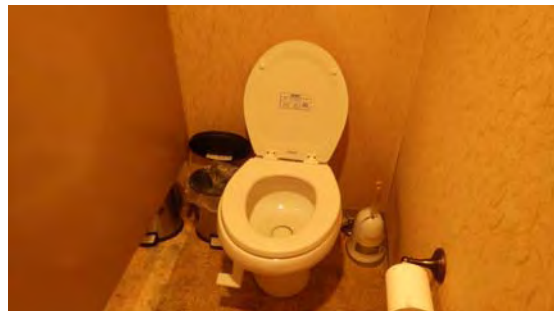
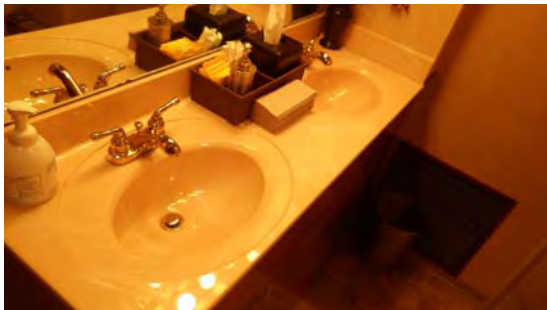
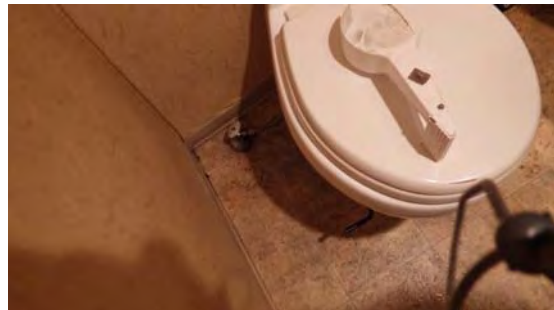
dated leak on water inlet.

Movement of toilet base on floor, water stains aft,

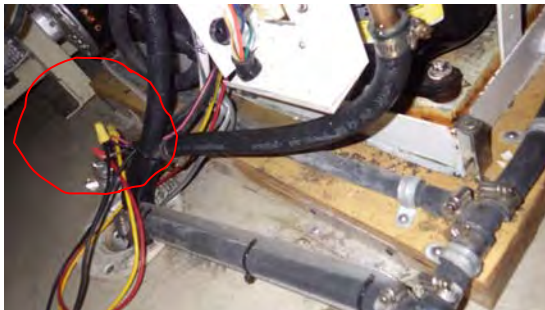
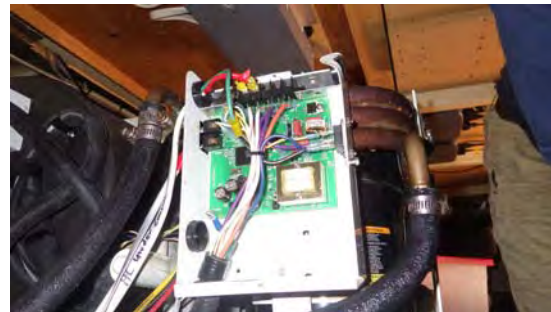
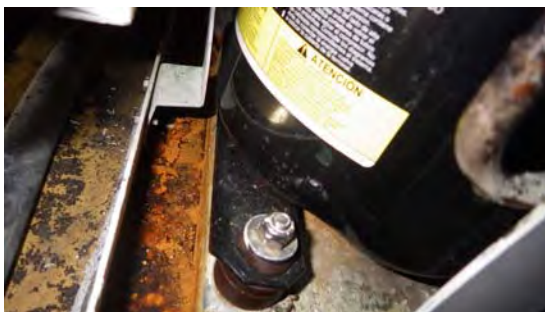
Flybridge AC unit under helm station Operational at inspection. Markings are not accessible or legible for size and rating. Control panel cover is removed. Condensate tray is dry, noted twist connectors on stranded wires. Exposed Alternating current termination.

- C. Twist Connectors not permitted for AC connections on stranded conductors. Present at Air Conditioner under helm and pumps in engine space (Par Fresh water pump red twists too large for conductor anyway)

- D. Air conditioner panel open to contact on AC terminations. Install cover.
- E. Air conditioner return air ventilation blocked by high chairs. Ducts are congested and dirty. Clean and service as required.

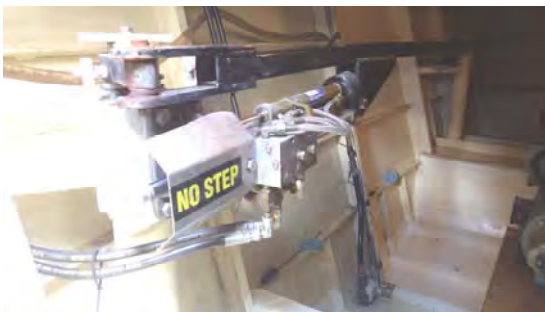
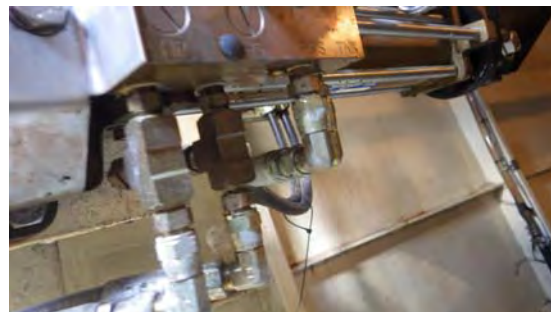
Type:	Hydraulic Sea Star with tie bar
Lines and fittings:	Lines secure, no leaks found
Pressure / reservoir tank:	No Leaks observed
Mounting(s):	Steering mountings and connections are loose. Improper sizing of hardware and nylock nuts are not engaged.
Rudder stock(s):	No observed issues.
Steering tie bar:	Deformed and bent upward over starboard rudder
Packing glands:	No leaks observed.
Steering Remarks:	Attend to fasteners and rusted bolts. Clean corrosion from fittings.
