Dufour, Laskay & Strouse, Inc.

General Condition
As of
May 15, 2013

M/V "HART IV"

SURVEY REPORT NO. 0529-54N13-B

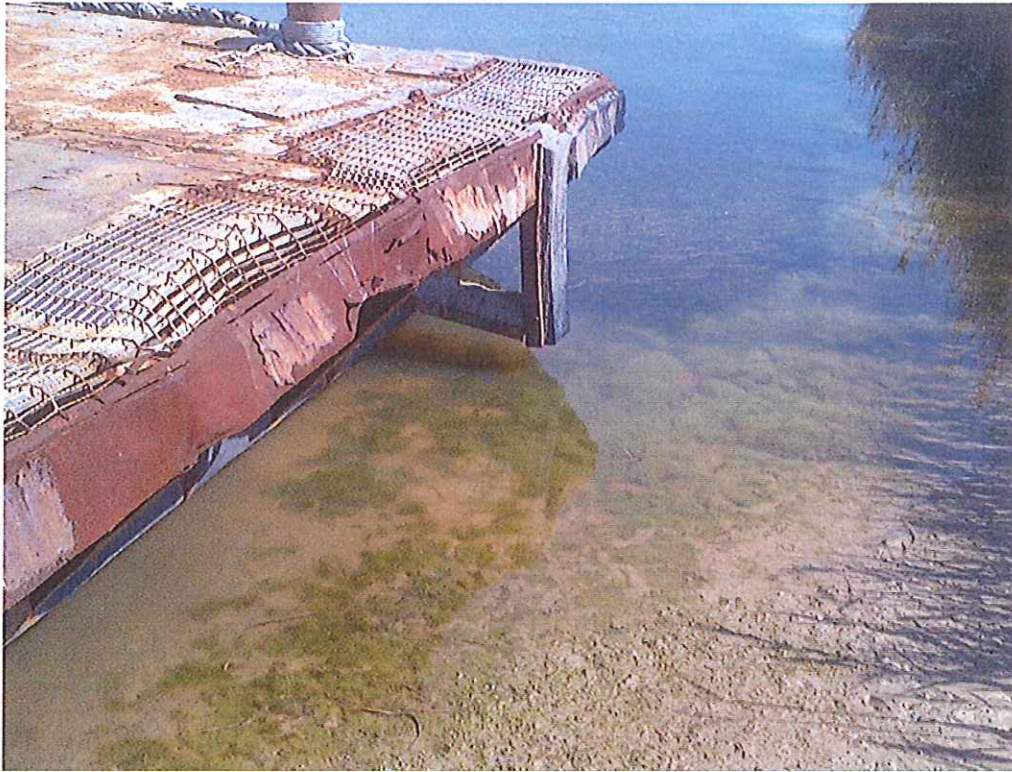
1. BOW OF VESSEL

The vessel's deck was found to be heavily washboarded and inset with approximately 20% of coatings remaining with moderate to heavy rust on the main deck. Several fiberglass patch repairs to the deck were noted. The sides had minor insets and fair coatings. The bow extension grating was heavily damaged and inset.

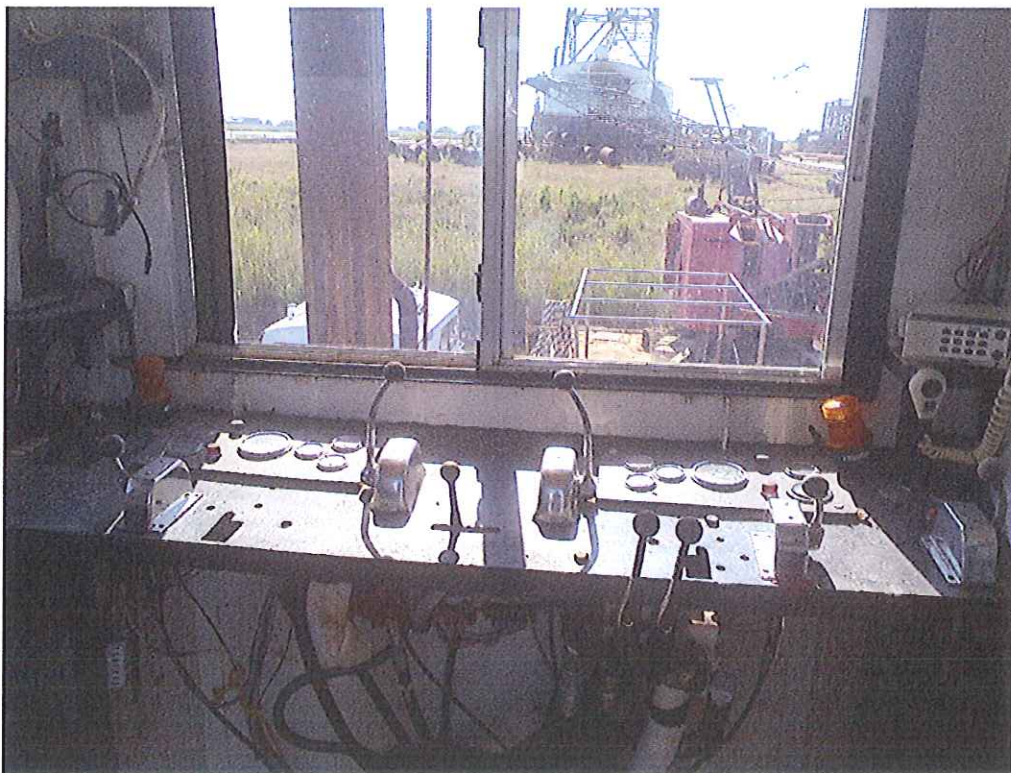
4. CONTROL CONSOLE OF PILOTHOUSE

The pilothouse equipment was reported to be in good condition and appeared adequate for a vessel in this service.

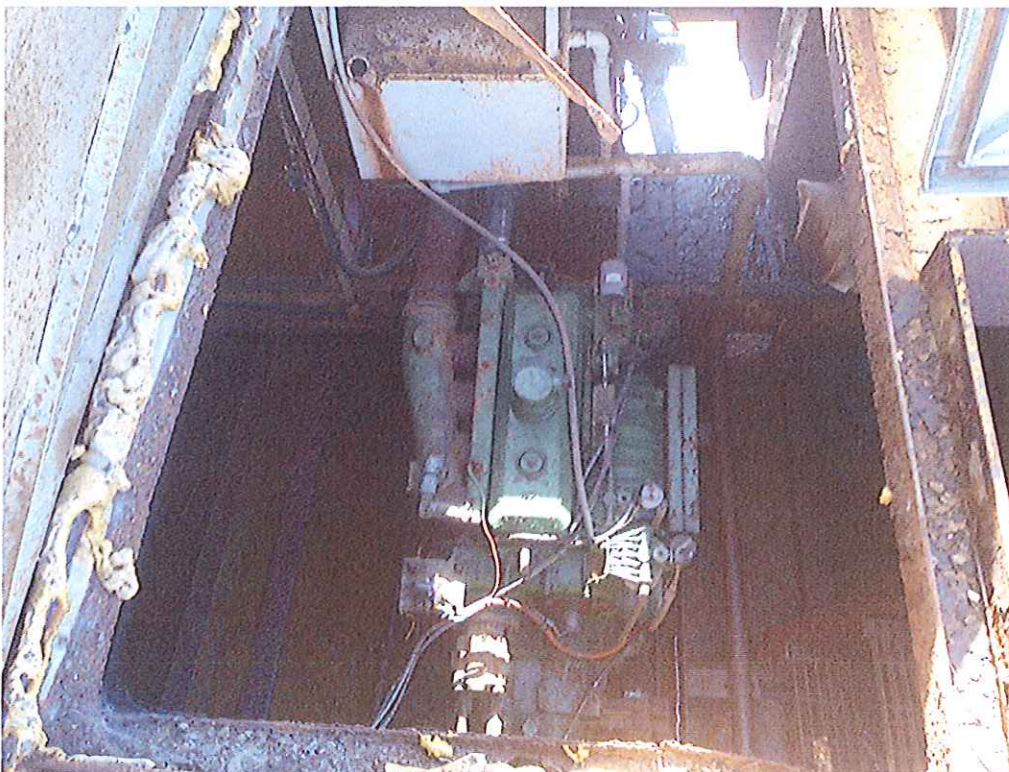
8. MAIN ENGINE

Main engines, generator engine, and hydraulic pump engine were found to be in fair condition with oil leaks.
