General Condition As of May 15, 2013

#### CREWBOAT "PEGASUS #90"

SURVEY REPORT NO. 0529-54N13-A

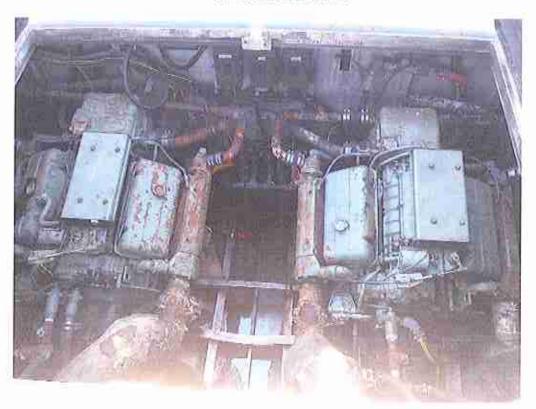
4. MAIN ENGINES

The machinery was not sighted in operation. The machinery was reported to be and appeared to be intact with signs of ongoing maintenance.

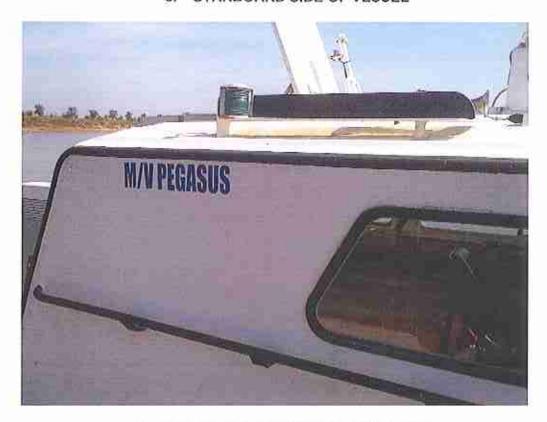
## 5. STARBOARD SIDE OF VESSEL

The vessel's hull was found to be in good condition with good coatings.

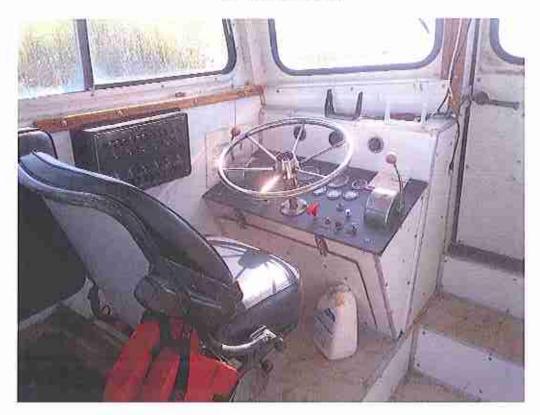
### 7. PILOTHOUSE

The pilothouse equipment was reported to be in good condition and appeared adequate for a vessel in this service.
