**Tugboat “CAPTAIN JERRY”  
Condition & Valuation Survey for Insurance**

24 May 2012

Location of Survey – Plaquemine, Louisiana at Verett’s Shipyard

**Report Number #12-30004**

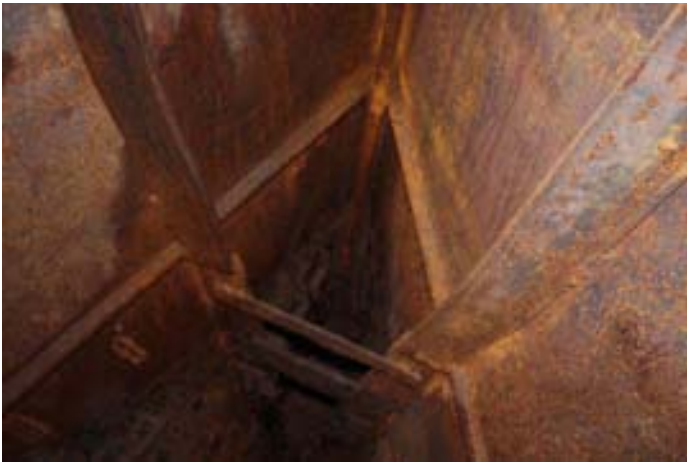
Forward Compartment -

All compartments were not entered as some were not prepared for entry. Forward ballast compartment and steering compartment hatches were opened and photographed from the deck. Compartments were rusted.

Covers to the two compartments that were opened did not appear to have been watertight and gaskets were in questionable condition.
