1979 Hatteras 58 Cockpit Motor Yacht
"NAN SEA GALE"

Report of Marine Survey

1979 Hatteras 58 Cockpit Motor Yacht

09 July 2013

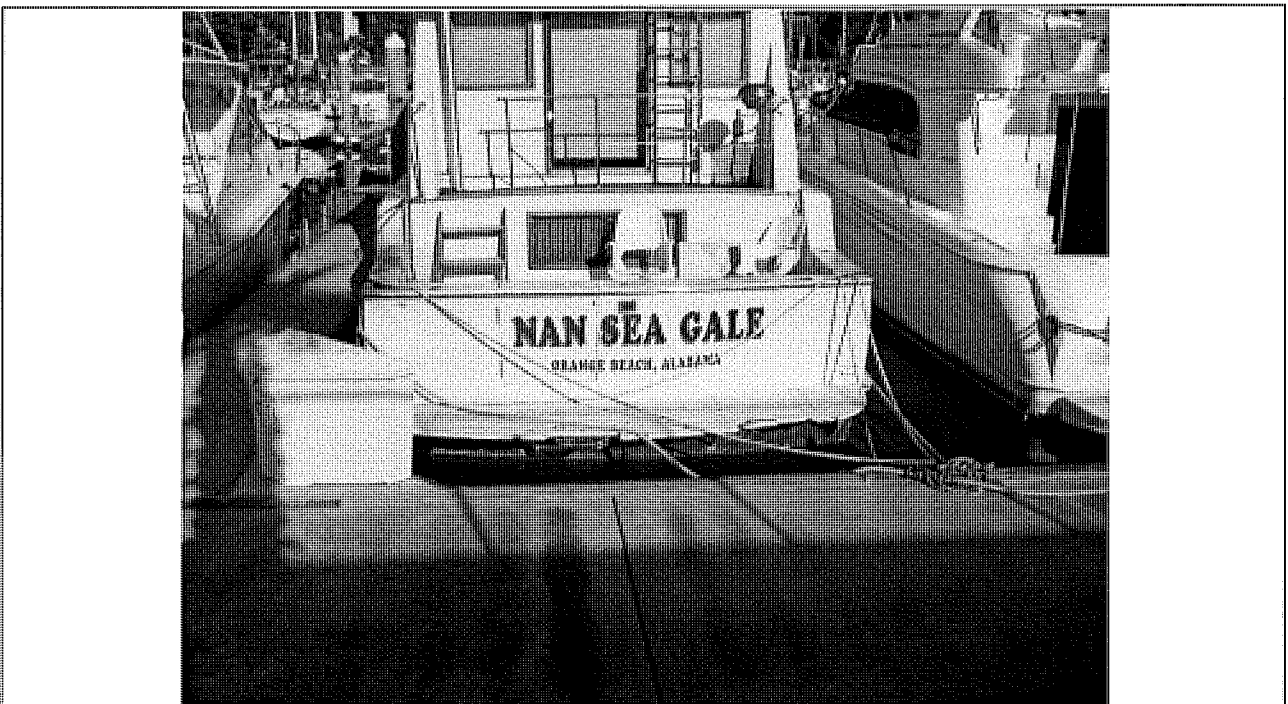
TRANSOM

FRP transom with outward opening transom door to port with hinged top gate in way. Moderate to heavy damage was noted on the bolt-on swim platform.

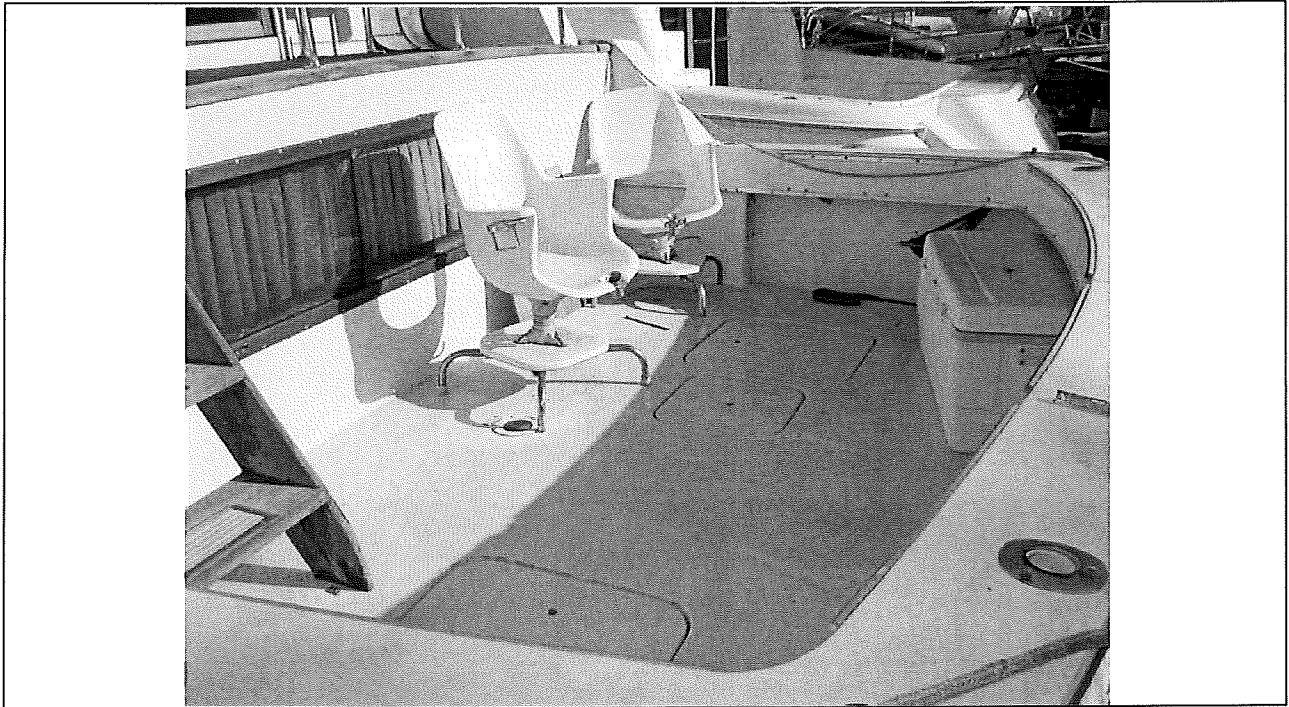
COCKPIT AREA

Aft recessed cockpit area. Teak steps forward to port in the cockpit area lead to the mezzanine and cabin entry door. Port and starboard aft flood lights tested operable. The starboard cockpit flood light was found to be damaged. Moisture levels were found to be elevated on the cockpit sole and high on the cockpit sole hatches.

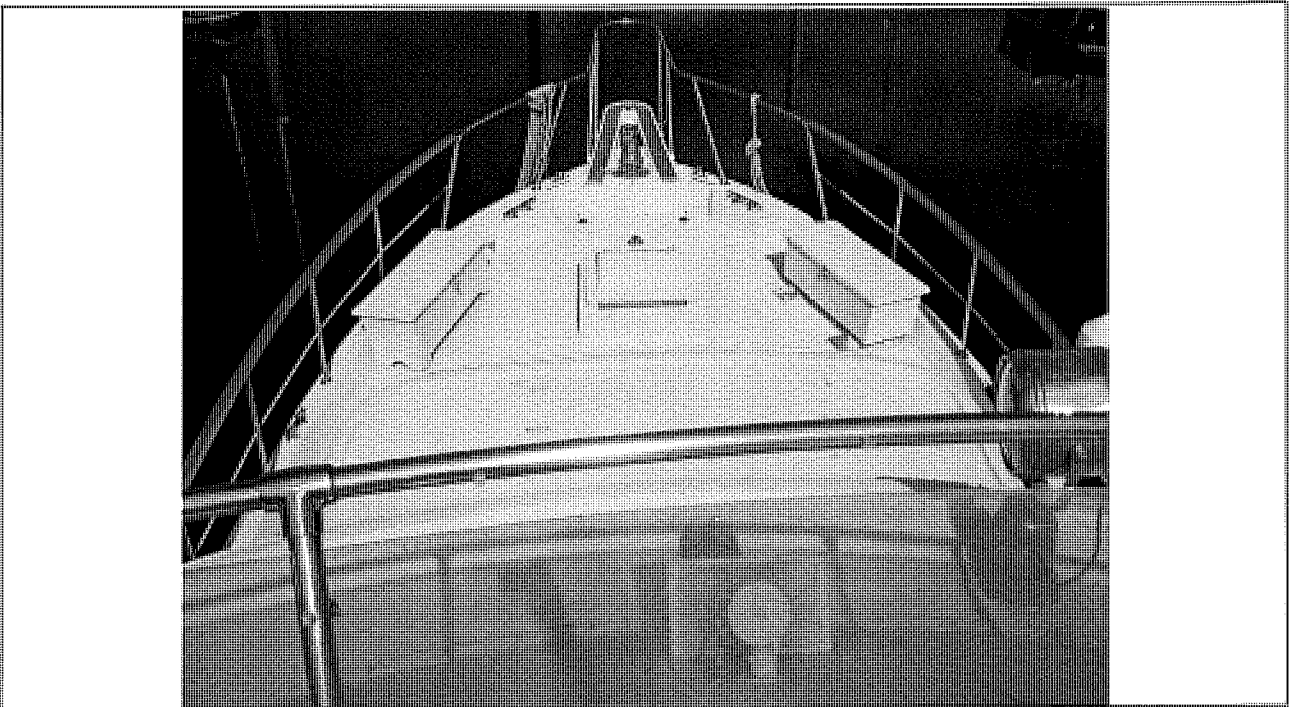
BOW DECK

Cored FRP with non-skid. Moisture levels were found to be high on the side decks, forward on the bow deck and in isolated areas on the bow trunk.
