## **REPORT OF MARINE SURVEY**

### **INSURANCE EVALUATION**

“Lake Queen”

1996 Skipper Liner 62 Paddle Wheel

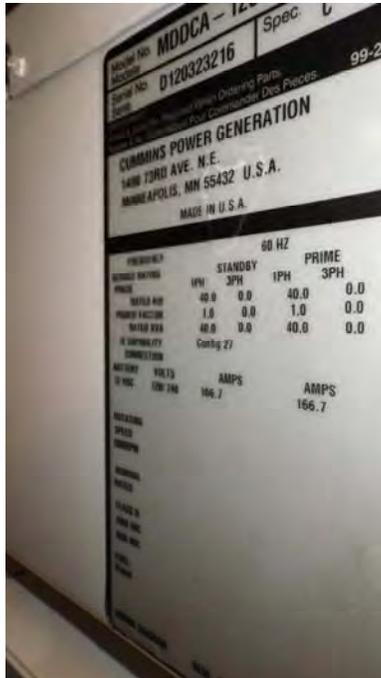
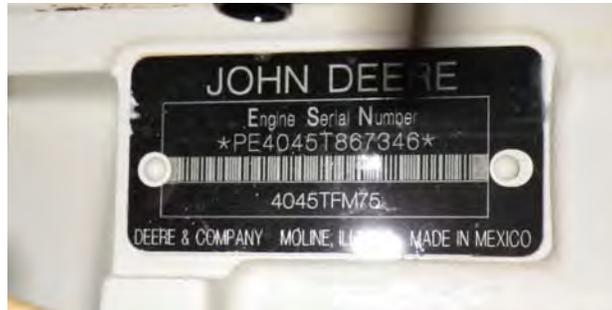
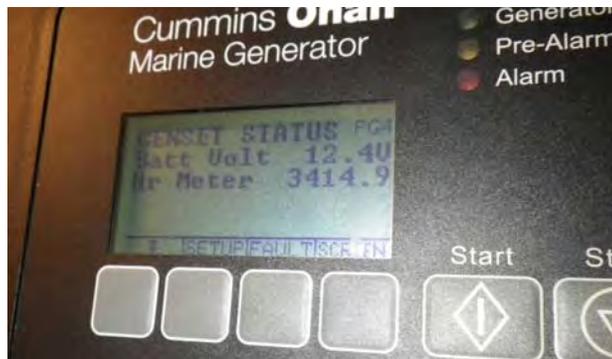
Hoses and clamps:	Double clamps Good
Belts and pulleys:	Good
Cooling system(s):	Low Reservoir fluid level
Oil level and condition:	Good
Fuel supply lines:	Good
Engine mounts and beds:	Good
Engine ground cable:	Good.
Exhaust piping:	Good
Muffler:	Good
Ventilation:	Good
Warning labels:	None

Generator was renewed reportedly two years ago. The condition and appearance of the generator concur with that report.

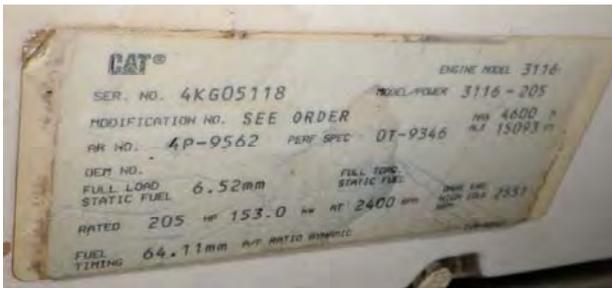
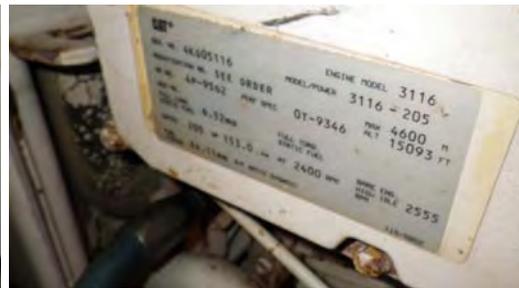
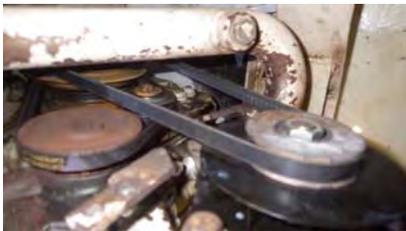
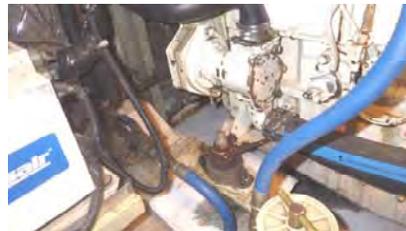
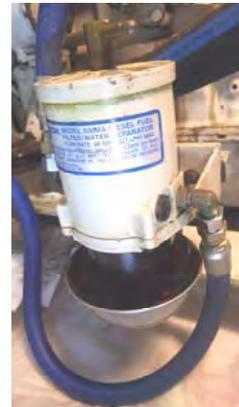
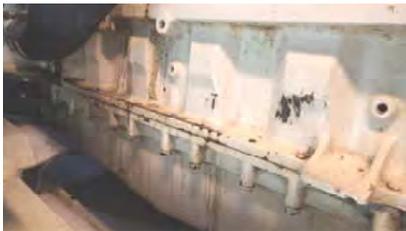
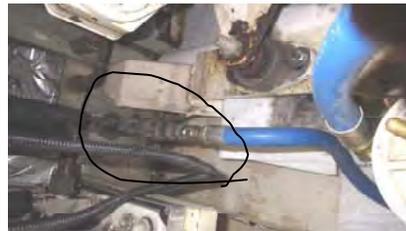
No. / Type / Cylinders	Caterpillar 205 H.P. 3116 - Diesel
Serial no(s):	5-4KG05118
Engine(s) hours:	Port – 1497.47 Starboard – 13,863.9
Raw water hoses:	Galvanized Piping
Belts and pulleys:	Good

Cooling system(s):	Good. Fluid in reservoirs depleted
Oil level and condition:	Good, not marked with dates on filters, normal appearance – not tested
Flame arrestor(s):	Not Applicable
Ignition protection:	No
Engine ventilation:	Good
Fuel supply lines:	Good
Fuel filter(s):	Good- 30 micron racor no Water Separating canisters.
Drip pad(s):	Yes – oil leaking inboard starboard engine onto drip pad.
Engine mounts and beds:	Rusted but appears secure.
Engine ground cable:	Grounding between engines & generator observed with 6 AWG wire.
Oil change system:	Yes

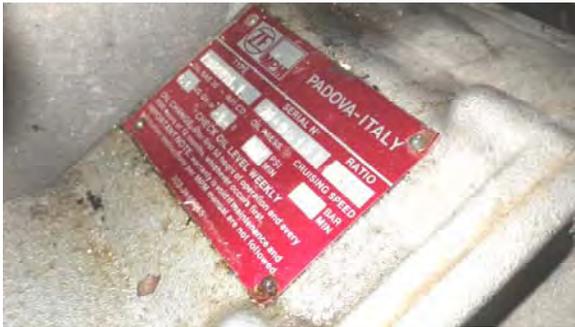
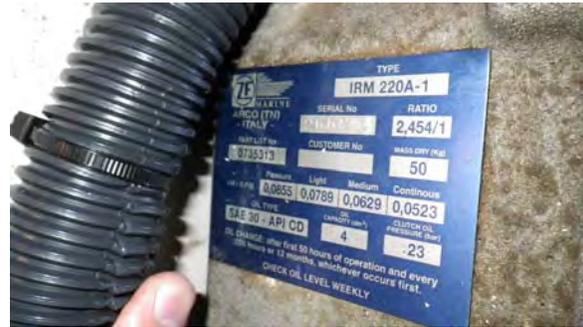
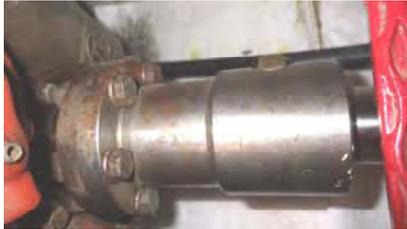
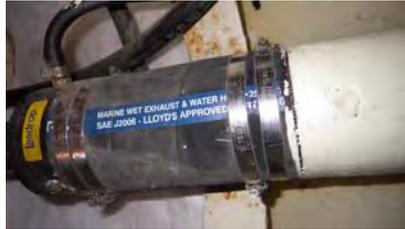
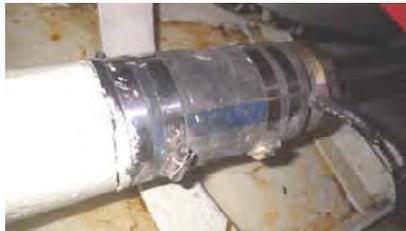
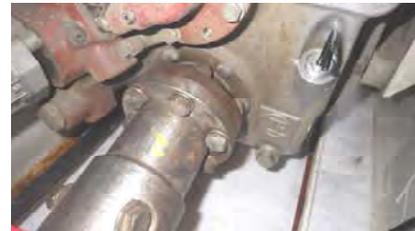
Manufacturer / model:	ZF IRM220A1
Serial no(s):	Port: 255995 Starboard: 95-05131
Gear ratio:	2.45:1
Fluid level and condition:	Port: Good Starboard: Good
Propeller shaft(s):	2" Stainless steel.
Stuffing box(es):	Good. Laddrop Dripless Packings

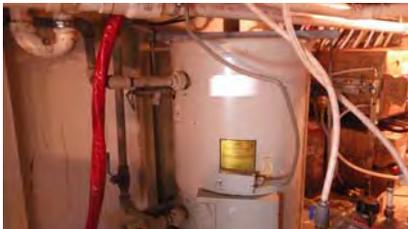
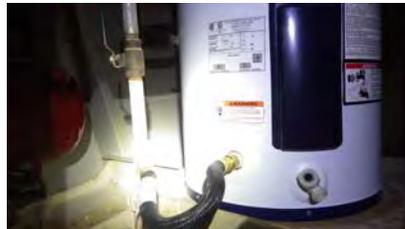
Tank location:	#5 (stern) compartment and #1 compartment under galley
Manufacturer / capacity:	Central Processing Corp forward / Craftmaster aft 19 gallon newly installed
How powered:	AC 120 volt
Water heater test:	Yes
Pressure relief valve(s):	Yes – mechanical operation of both proper working condition
Drain fixture(s) / plug(s):	Surface corrosion apparent.
Supply lines:	No recommendations
Outer tank material:	Steel. Rusting is present on both units
Tank(s) secured:	Forward yes, aft yes.
Inspection / cleaning access	Unrestricted cleaning / draining of tank
Ignition protected:	No – not necessary in compartments installed in.
Other notes:

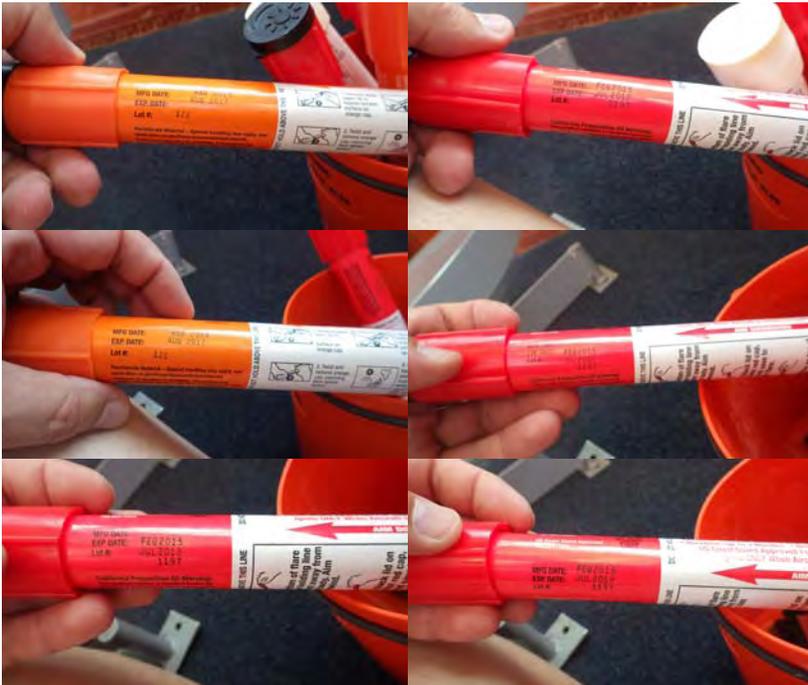
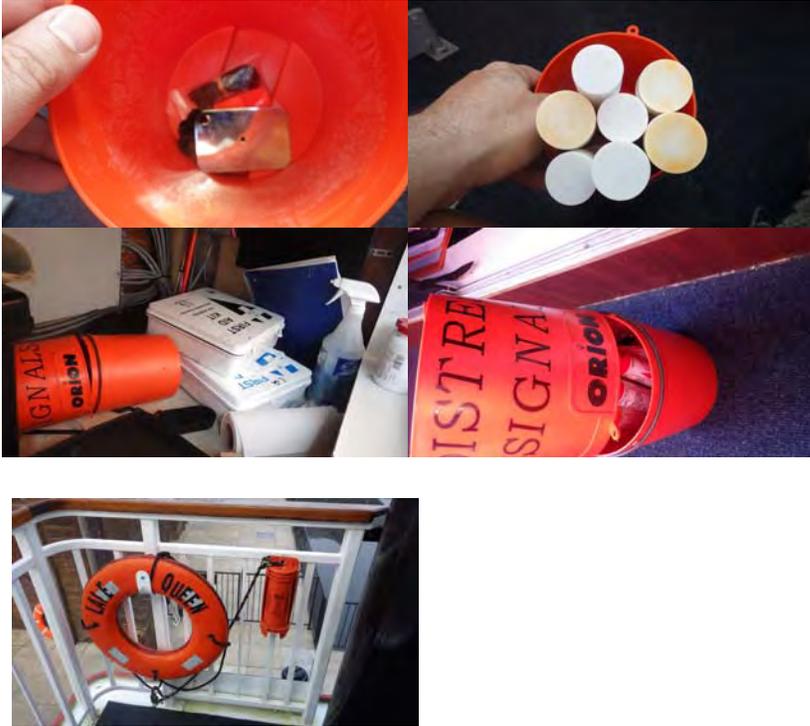
Navigation lights:	At inspection, sternlight was inoperative. This was corrected via the replacement of the entire assembly prior to my departure and confirmed.
Life jackets (PFD's):	23,23,23,23,23 (16) 23 containers of Maye West design life vests with reflectors. 16 constitutes legal requirement for child life vests.
Throwable type PFD's:	Two rings with beacon operational
Visual Distress Signals:	Flares- all inspected with current dates.
Sound devices:	Horn
U.S.C.G. placards:	Waste observed at galley, oil to hatch at engine room
Engine ventilation:	Manual closure
Inland Navigation Rule Book:	None – requirement of law for vessels over 13 meter.

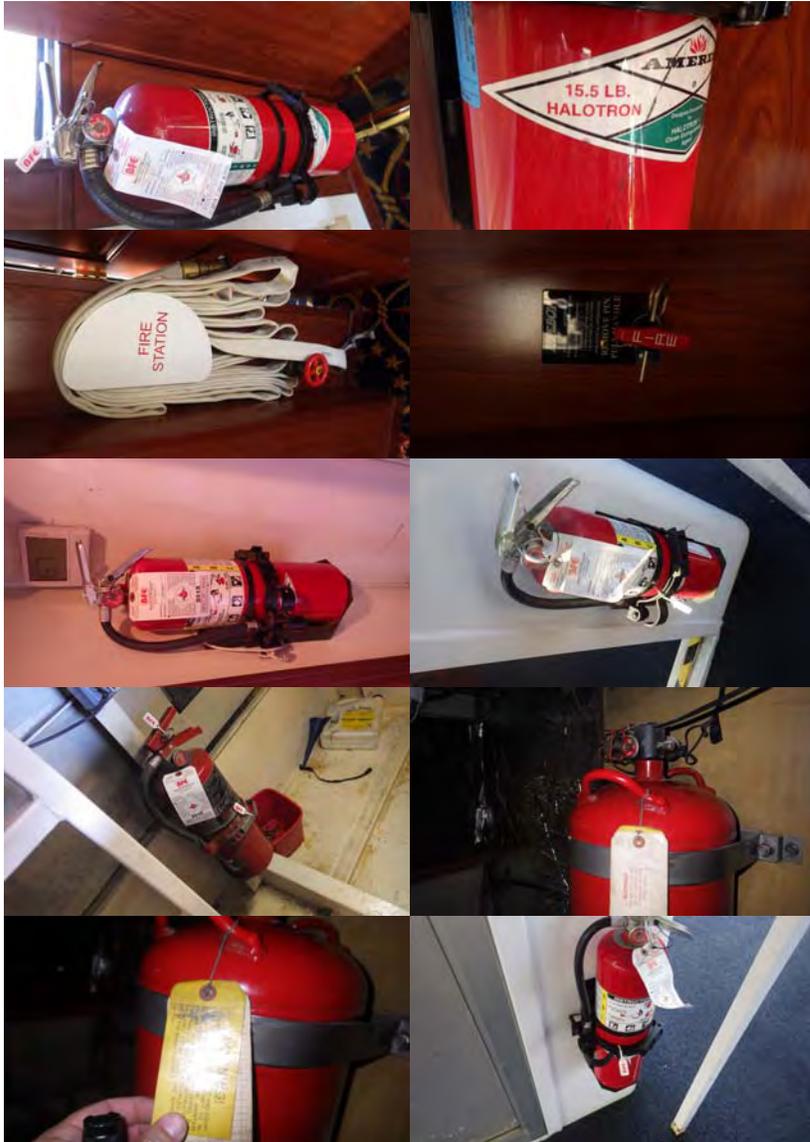
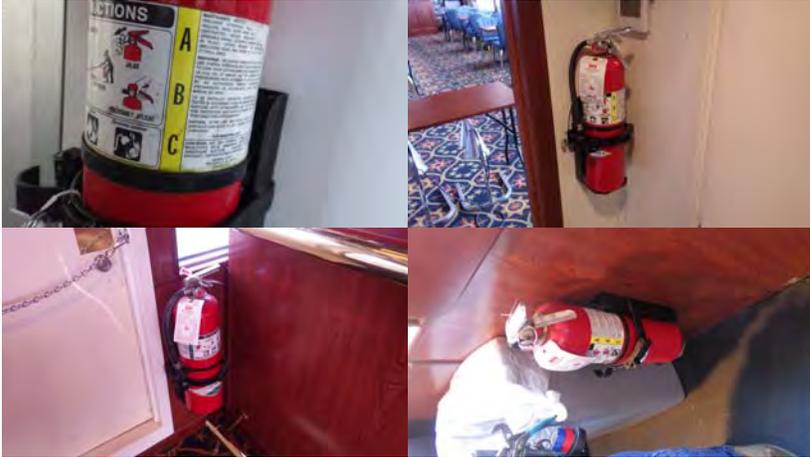
Dry Chemical Size I:	Engine room, aft bar, main cabin port side, galley, upper deck by pilot house (5 total) Classification 2-A:10-B:C Halotron May 2015 inspections
Fixed / Clean Agent:	FE 241 30 pound Model MA2-900
FIRE EQUIPMENT OBSERVATIONS:	NOTES: Manual discharge secure & pinned adjacent to heads & lower fire station. Hose at stern by heads & upper deck port side railing

Scentry indicator on extinguisher discharge  
in engine room.

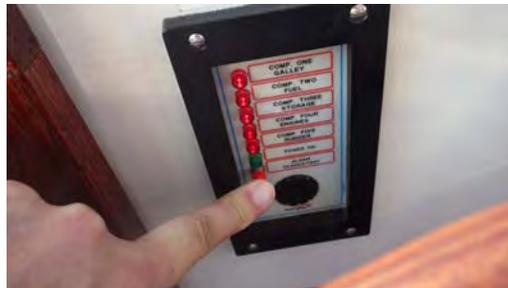
Forward bilge:	Main vessel dewatering pump only engine driven
Engine compartment:	None
Bilge Pump Comments:	Float sensors in pilot house all functional at test.
