REPORT OF MARINE SURVEY

INSURANCE EVALUATION

“Landing Princess”
2007 Skipper Liner 96’ MY Series 1017

CONDUCTED BY:
Michael Hunter, NAMS-CMS, SAMS-AMS
On
August 11, 2015

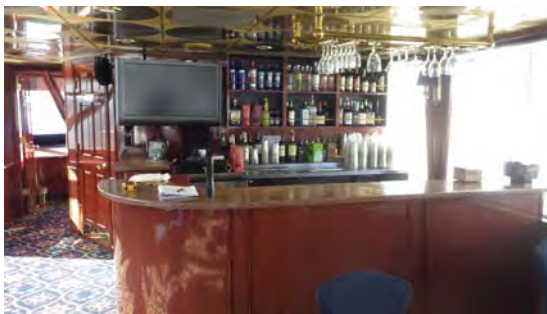
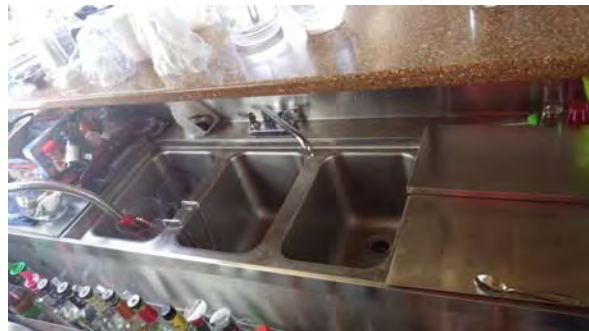
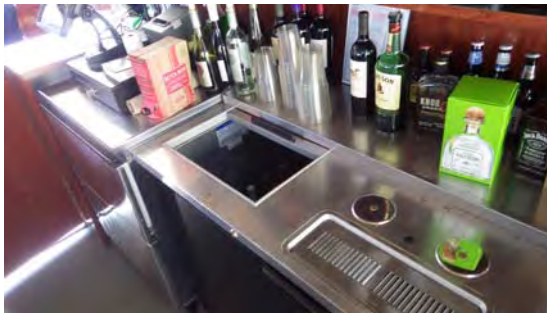
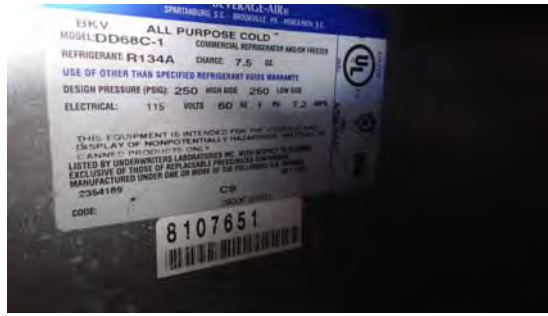
BAR (upper)

Location: : Upper deck
 Stove: None
 Refrigeration: Single system under counter with double doors with topside access on both right and left sides. Manufacturer name, make and model not specified. NOTE: filters and intakes are dirty and require cleaning.
 Ice maker: Hoshizaki installed below counter left side bar.
 Sinks: Three basin sanitizing
 Garbage disposal: None
 Vent fan: None
 Storage: None

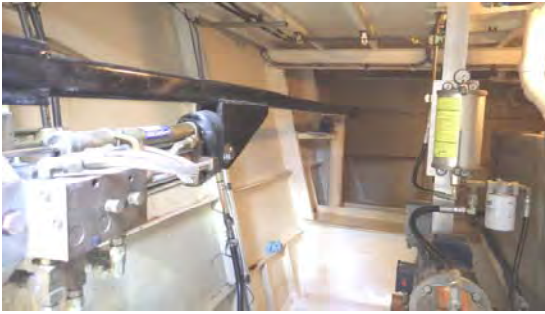
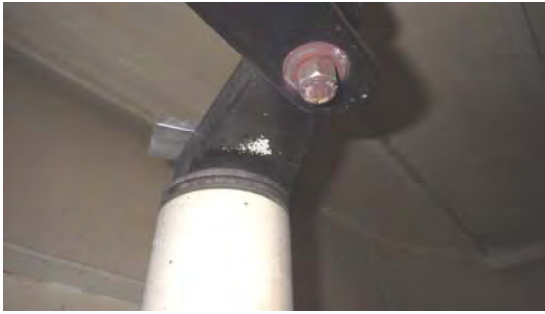
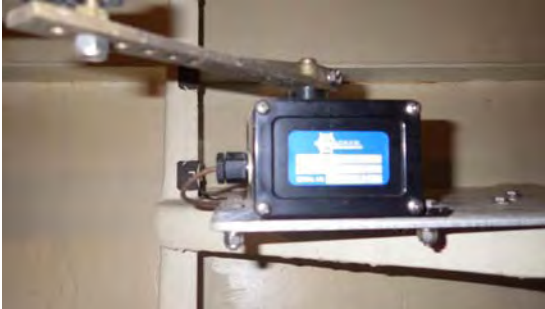
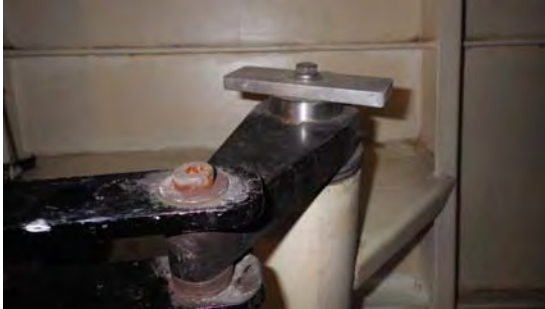
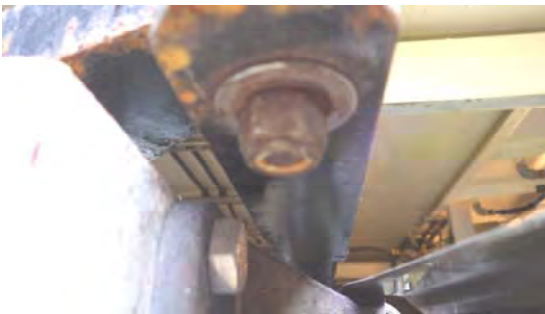
Type:	Hydraulic Sea Star with tie bar
Lines and fittings:	Lines secure, no leaks found
Pressure / reservoir tank:	No Leaks observed
Mounting(s):	Steering mountings and connections are loose. Improper sizing of hardware and nylock nuts are not engaged.
Rudder stock(s):	No observed issues.
Steering tie bar:	Deformed and bent upward over starboard rudder
Packing glands:	No leaks observed.
Steering Remarks:	Attend to fasteners and rusted bolts. Clean corrosion from fittings.

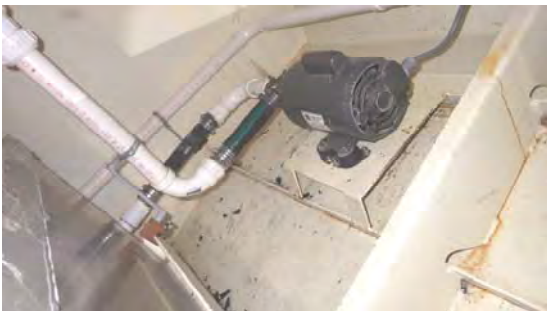
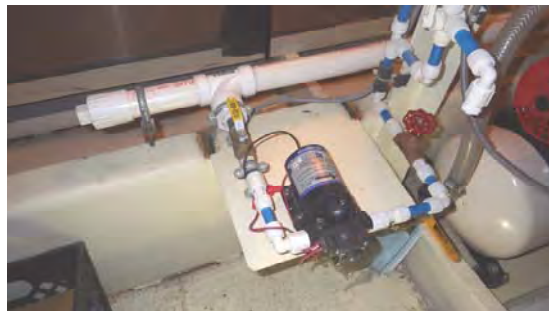
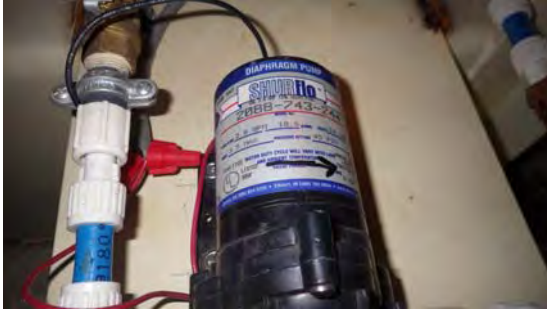
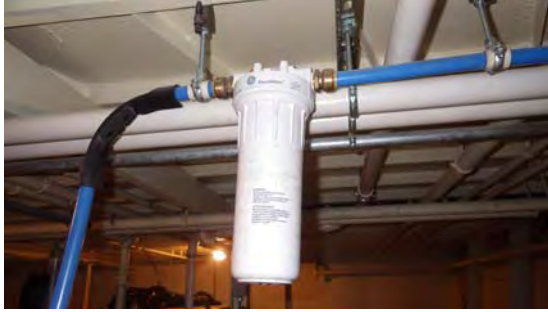
Fill Caps are padlocked.

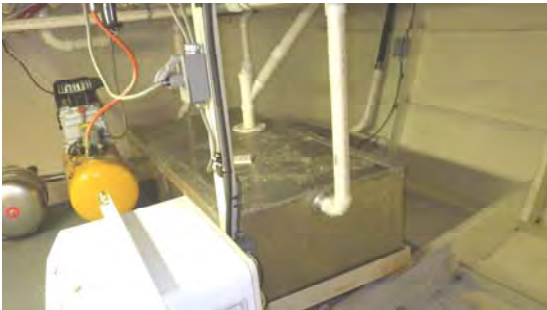
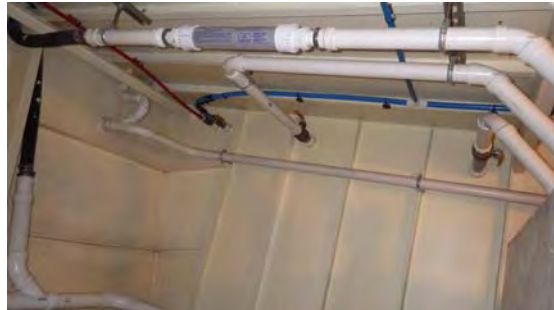
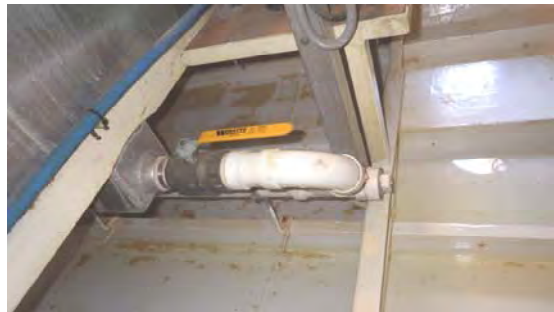
None - aft vent line is equipped with filter

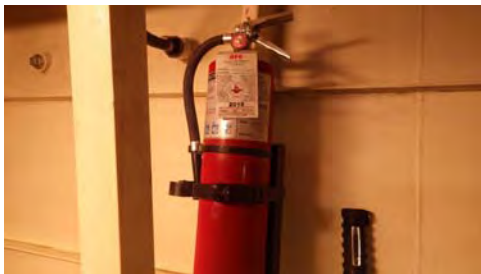
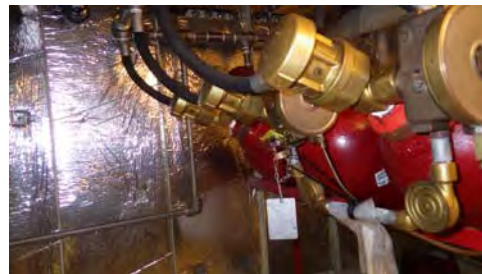
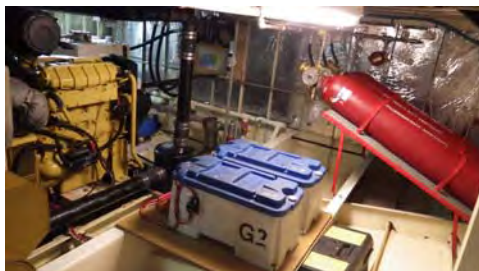
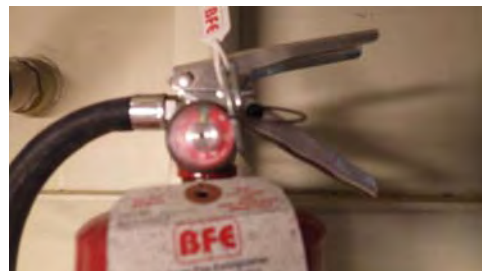
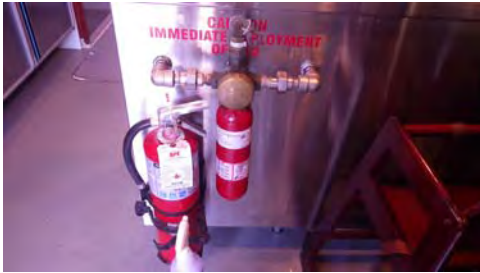
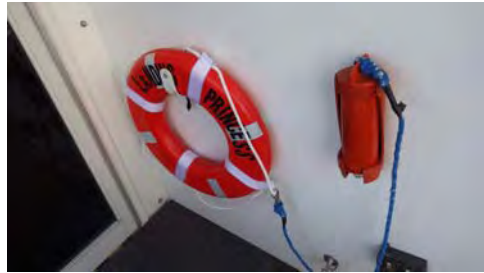
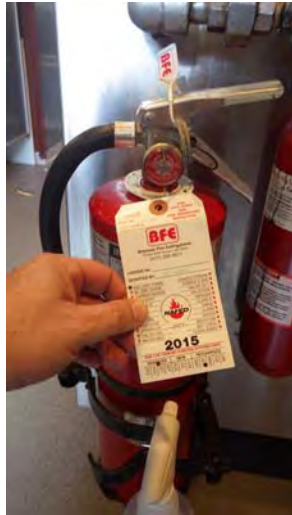
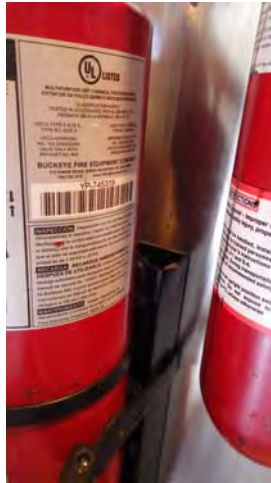
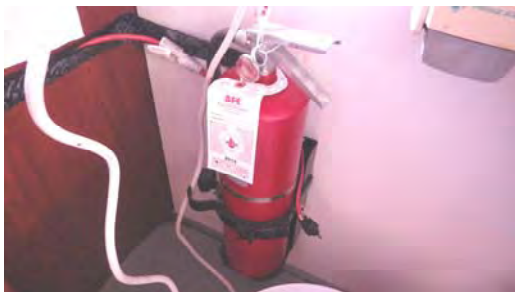
All extinguishers on vessel inspected and recertified April 2015 by Branson Fire Extinguishers.

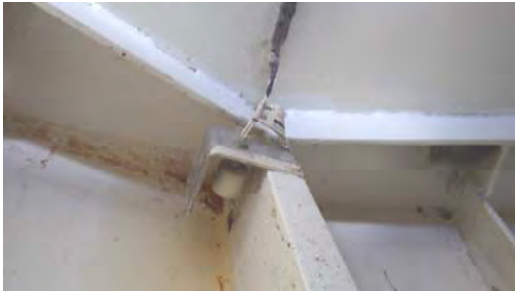
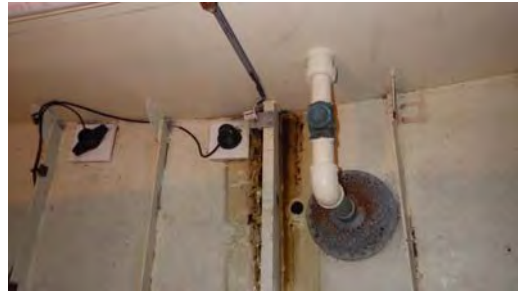
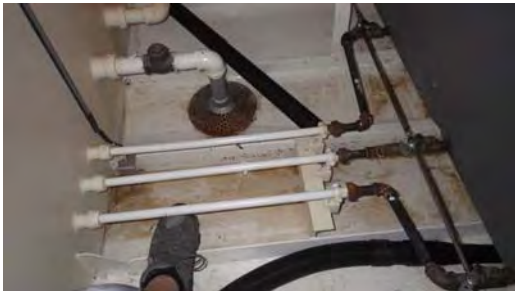
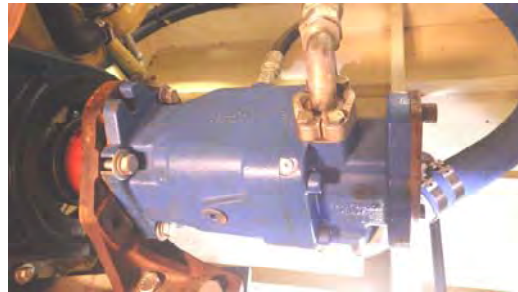
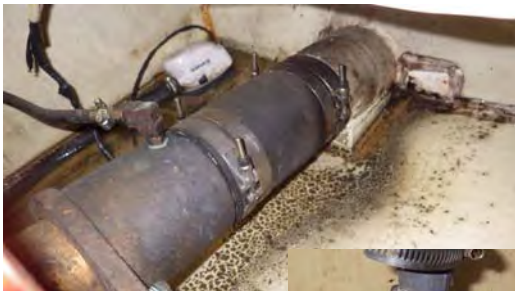
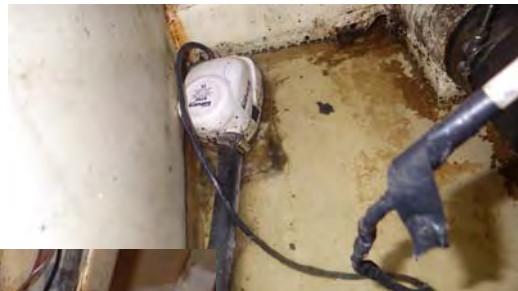
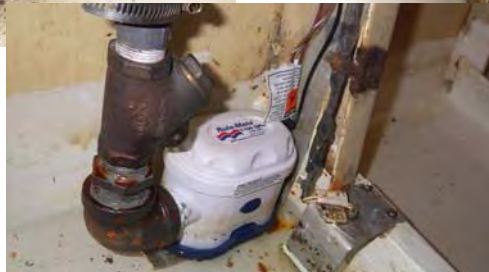
Forward bilge:	Dewatering system vessel emergency evacuation via Aux. Generator pump each bilge separate electronic water sensors to helm 1000 gph Rule Lazarette 24VDC
Bilge Pump Comments:	Manual Dewatering system about the vessel bilges. Auxiliary Attwood Sahara 750 GPH or 500 Automatic bilge pumps in each compartment shaft well, with pumps in each shaft sump engine room being renewed at time of survey. Its operation could not be confirmed.
