**Tugboat “CAPTAIN JERRY”  
Condition & Valuation Survey for Insurance**

24 May 2012

Location of Survey – Plaquemine, Louisiana at Verett’s Shipyard

**Report Number #12-30004**

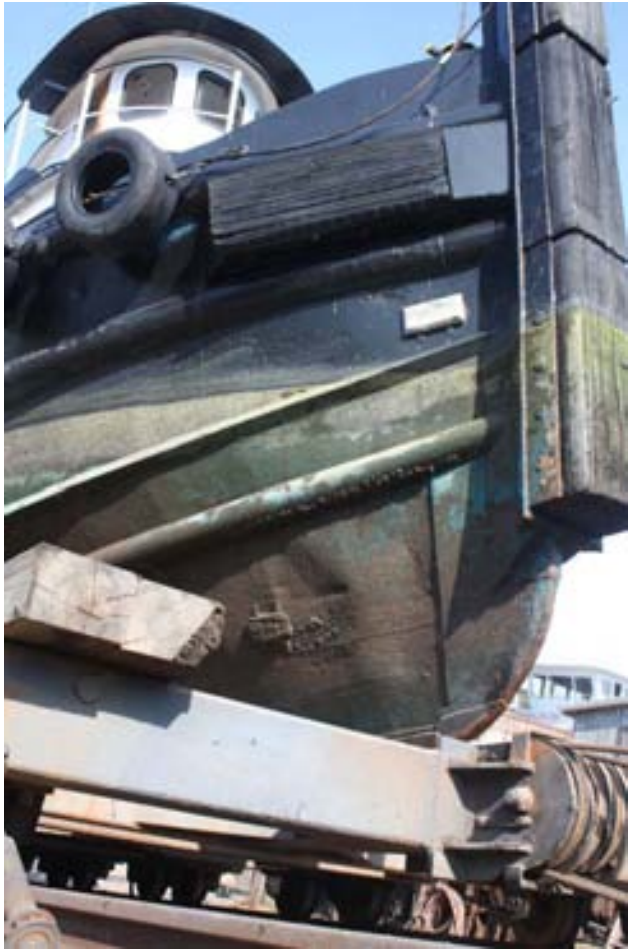
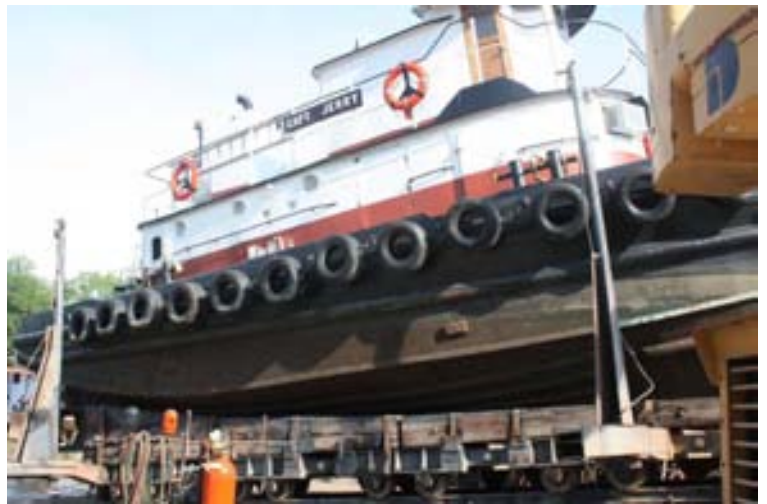
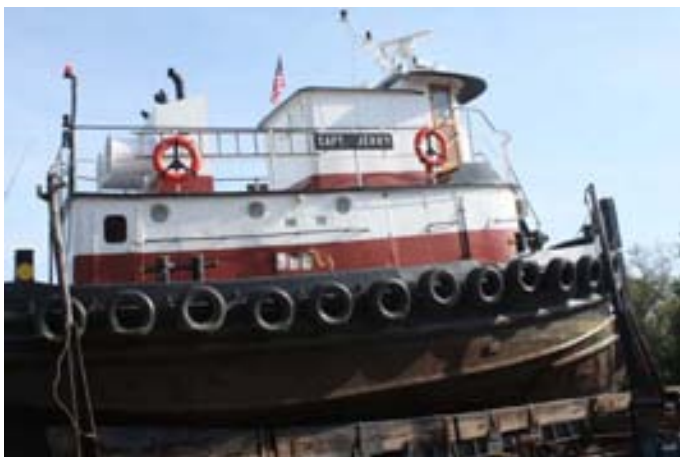
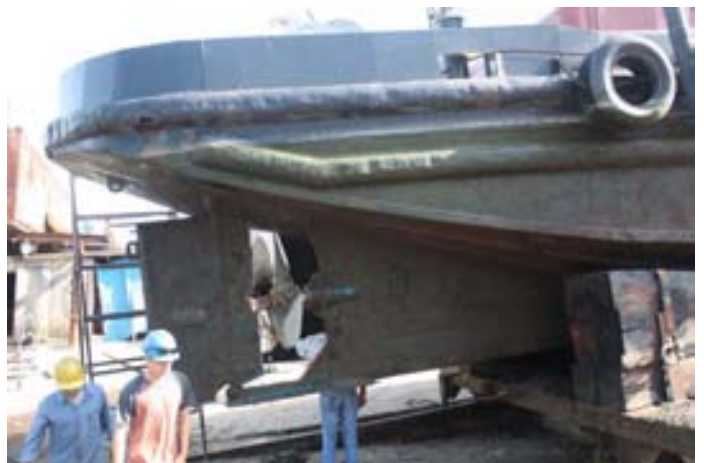
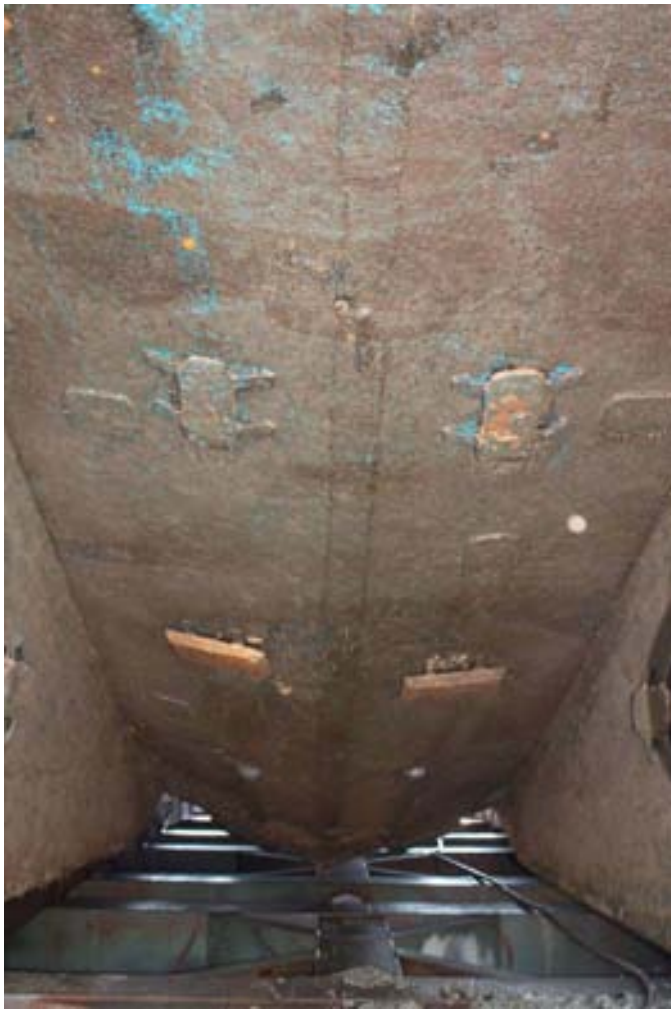
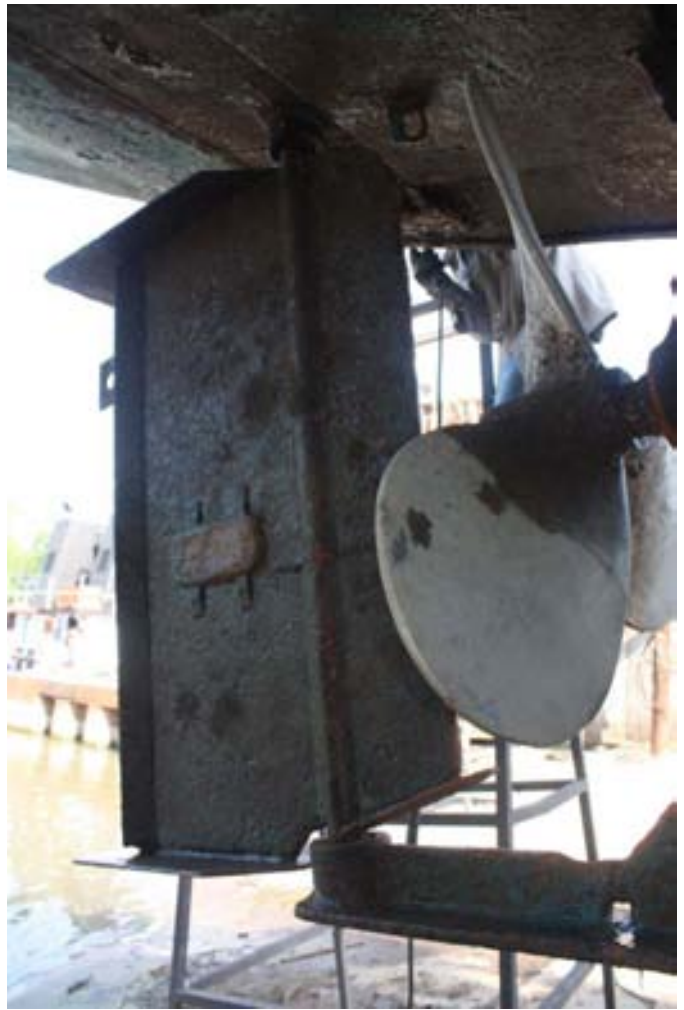
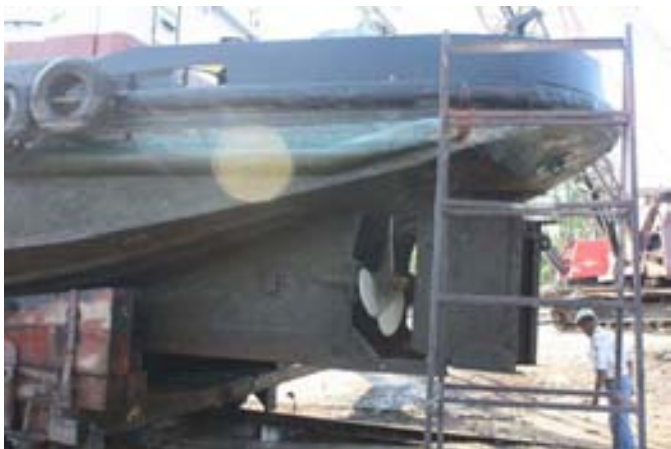
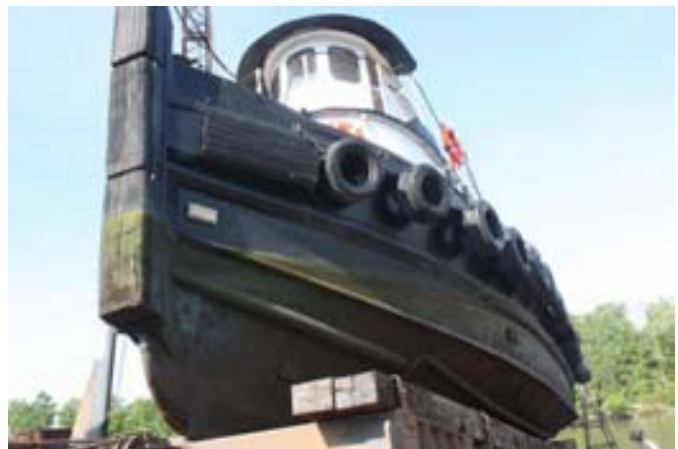
**Lower Hull -**

Lower hull coating appeared to be in fairly good condition and about 80% effective.

Indents to the lower hull appeared to be relatively minimum. No heavy damages were noted. The rubrails and bulwarks displayed numerous zero to about two inch indents which are common for a boat of this type.

No excessively heavy damages were noted to the hull as sighted on dry dock. Protective coating appeared to be about 75% effective.

A keel cooler was leaking. At time of inspection the owner had the shipyard weld up the leak. We understand that these will be check at next scheduled dry docking and attended to accordingly
