Report of Marine Survey

Condition & Valuation

M/V SCHATZ II

Survey Report No. 20-1024

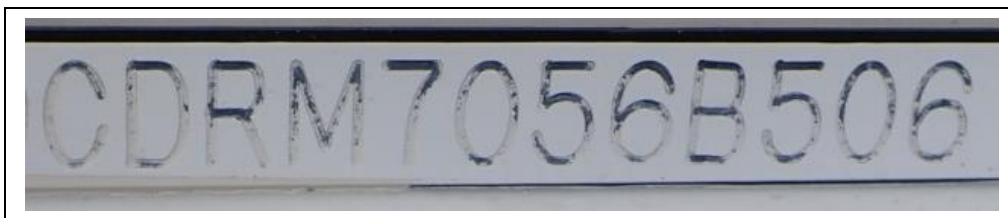
HIN: CDRM7056B506

I CERTIFY THAT THE PHOTO OF THE HULL IDENTIFICATION NUMBER (HIN), WHICH
APPEARS BELOW ON THIS DOCUMENT, WAS TAKEN ON THE DATE INDICATED
BELOW.

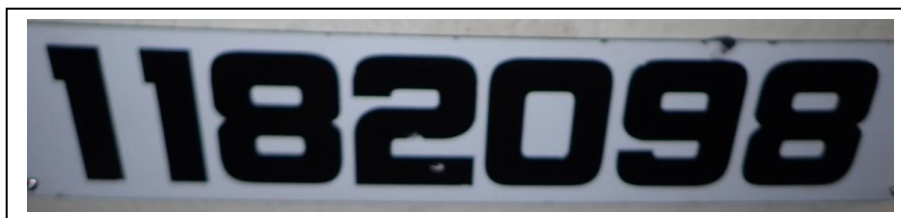
USCG Doc. No.: 1182098
